# ANALYSIS OF CAUSES OF ICING CONDITIONS WHICH CONTRIBUTED TO THE CRASH OF CONTINENTAL FLIGHT 3407

Frederick R. Mosher\*, Debbie Schaum, Chris Herbster, Tom Guinn

Embry-Riddle Aeronautical University, Daytona Beach, FL

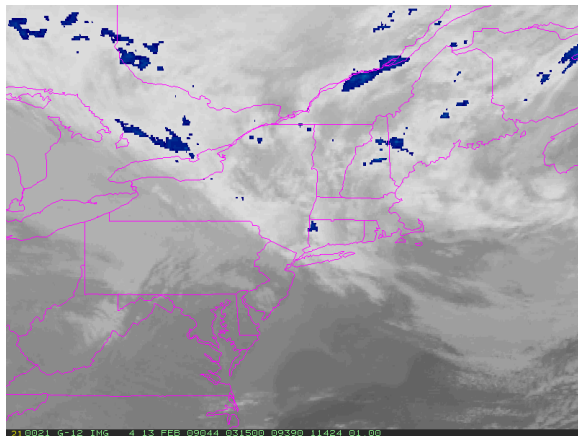
Figure 1 shows the IR satellite image for New England while Figure 2 shows a blowup of the western New York region with enhancements showing the 0 to -10 range (yellows), -10 to -20, and colder than -20 (blues). The cloud top temperatures in western New York are -15 °C.

Figure 1. IR image 3:15Z

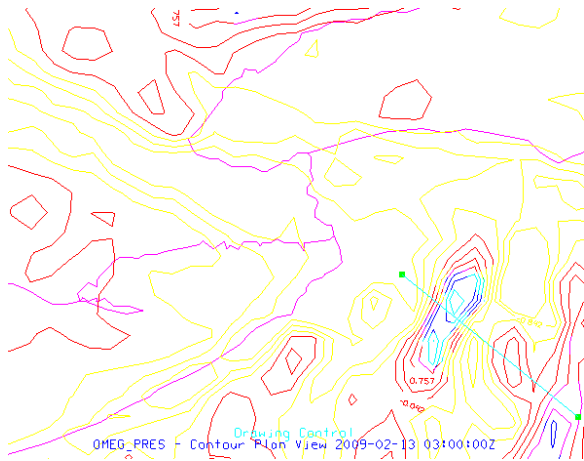
winds encounter hills or mountains and are forced upward by the terrain. To investigate this possibility, we ran the WRF model over western New York using the RUC OZ data as the initial conditions. The model was run at a 10 km resolution as well as a 6 km resolution. The results were nearly identical for both runs. Figure 4 shows the vertical motion contours at 850 mb (about 4,500 ft.) at 03 Z for the 10 km run. The straight line shows the path of Flight 3407. The red and blue contours are upward vertical motions. The yellow contours are downward vertical motions.

Figure 4. Vertical motion at 850 mb (approximately 4,500 ft.) at 3Z from the WRF model simulation. Straight line is path of Flight 3407.

The enhanced upward vertical motion in western New York was over enhanced terrain. The enhanced vertical motion was persistent in this area during the entire 3 hours of the model simulation. This was also the only area of enhanced vertical motions in western New York which would explain why other aircraft did not encounter the severe icing. If the upward vertical motion in a cloud is faster than the downward fall speed of the droplets, the cloud droplets will be swept upward toward the cloud top where the upward motion stops. This will

cause an accumulation zone of liquid water near the cloud top, which can increase the liquid water content of the cloud. This accumulation zone of liquid water appears to be responsible for the rapid buildup of ice as Flight 3407 descended into the cloud.
