# ANALYSIS OF CAUSES OF ICING CONDITIONS WHICH CONTRIBUTED TO THE CRASH OF CONTINENTAL FLIGHT 3407

P3.3

Frederick R. Mosher\*, Debbie Schaum, Chris Herbster, Tom Guinn

Embry-Riddle Aeronautical University, Daytona Beach, FL

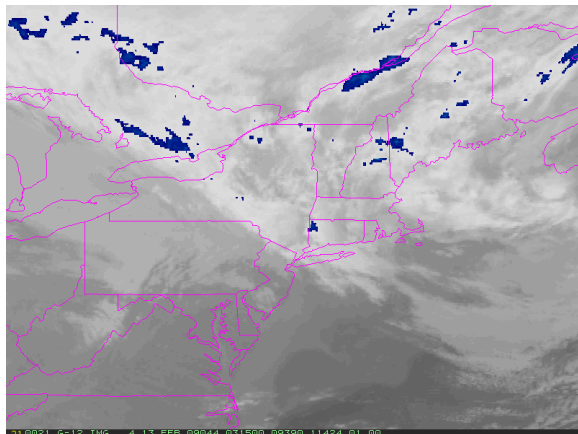
Figure 1 shows the IR satellite image for New England while Figure 2 shows a blowup of the western New York region with enhancements showing the 0 to -10 range (yellows), -10 to -20, and colder than -20 (blues). The cloud top temperatures in western New York are -15 °C.

Figure 1. IR image 3:15Z

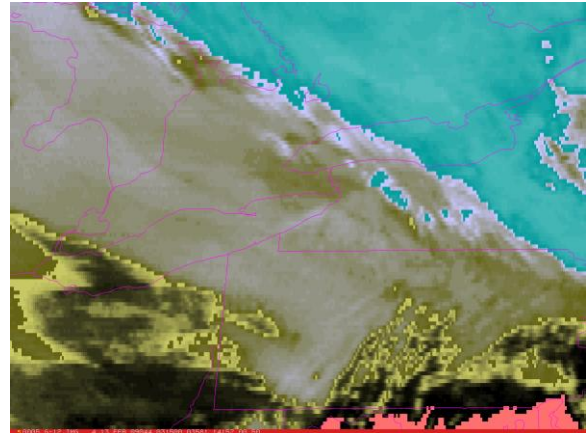
Figure 2 . Enhanced IR image of western New York at 3:15Z with 0 to -10 being the yellows, -10 to -20 being the browns, and colder than -20 °C being the blues.

In the Ohio valley there was a zonal jet core at 250 mb. The western New York area was in the left front quadrant of the jet, which generally is an area of upper level divergence and upward vertical motion. However the influence of the jet appears to be primarily limited to the upper level clouds, such as the higher clouds in northern and central New York shown in fig. 2.

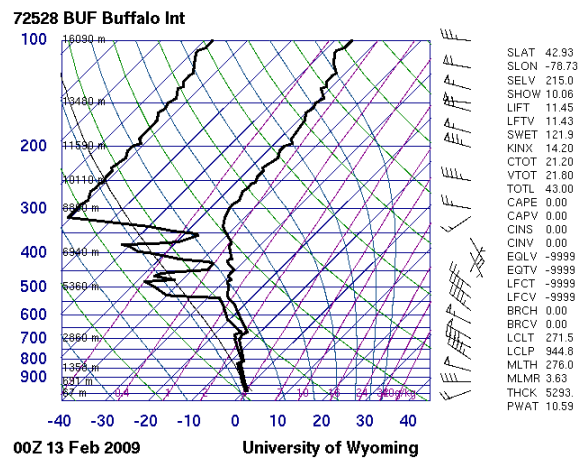
The OZ sounding from Buffalo is shown in figure 3. The digital listing of the sounding shows that the -15°C cloud top height was at approximately 11,000 ft. The 03Z surface observation from Buffalo showed an overcast cloud base of approximately 2,100 ft.

Figure 3. SkewT diagram of the OZ sounding from Buffalo.

temperature profile to be absolutely stable (air temperature decreasing with height more slowly than the moist adiabatic lapse rate). Hence upright convection does not appear to be a cause of the vertical motions.

The Buffalo 0Z sounding shown in figure 3 shows the winds at the surface from the west southwest at 20 knots veering to the west northwest at 50 knots at 850 mb. This veering wind profile is associated with warm advection and lifting. The prefrontal conditions represented by this sounding would have sufficient vertical motions to cause the stratus cloud mass covering western New York, the light precipitation, and the light aircraft icing conditions, but not necessarily the severe icing conditions encountered by Flight 3407.

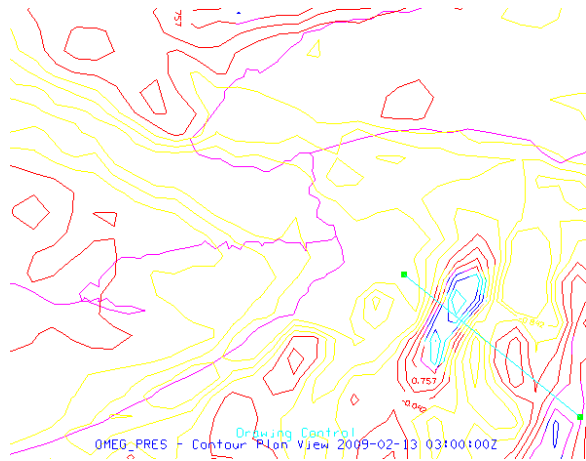
Figure 4. Vertical motion at 850 mb (approximately 4,500 ft.) at 3Z from the WRF model simulation. Straight line is path of Flight 3407.

The enhanced upward vertical motion in western New York was over enhanced terrain. The enhanced vertical motion was persistent in this area during the entire 3 hours of the model simulation. This was also the only area of enhanced vertical motions in western New York which would explain why other aircraft did not encounter the severe icing. If the upward vertical motion in a cloud is faster than the downward fall speed of the droplets, the cloud droplets will be swept upward toward the cloud top where the upward motion stops. This will

cause an accumulation zone of liquid water near the cloud top, which can increase the liquid water content of the cloud. This accumulation zone of liquid water appears to be responsible for the rapid buildup of ice as Flight 3407 descended into the cloud.

An area for future development would be to incorporate the high resolution vertical motion information currently available in numerical models into icing diagnostic and forecast products.
