The Gulfstream IV operator had all the appearance of a good operation but the flightcrew lacked cockpit discipline

NTSB finds widespread non-compliance with checklist use and control checks, leading to this tragic BED runway overrun crash.

By Robert Sumwalt
NTSB Board Member
ATP/CFII/FE. Airbus A320, King Air 350, Boeing 737, Fokker F28, Fokker 100

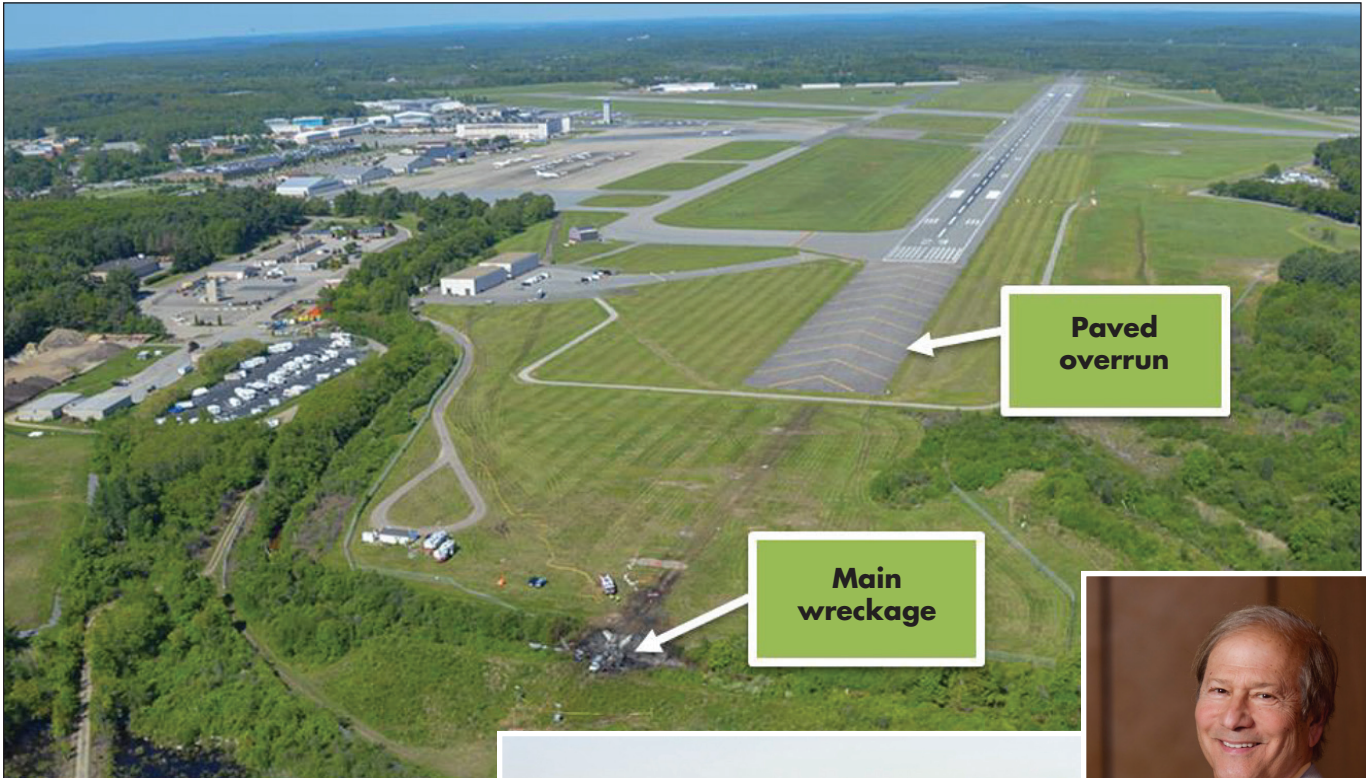
Source: Massachusetts State Police

Flightcrew failure to review the checklist and release the gust lock prior to the takeoff run of Gulfstream IV N121JM on BED's 7000-ft Rwy 11 as well as failure to be time-sensitive and abort the takeoff before running out of runway length led to destruction of the aircraft and the deaths of all occupants aboard.

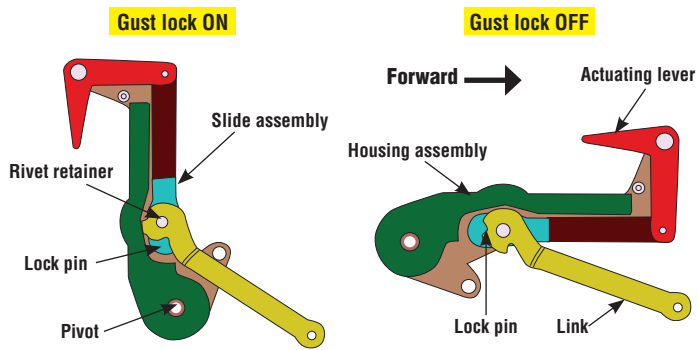
Diagram of a gust lock handle in the ON and OFF positions

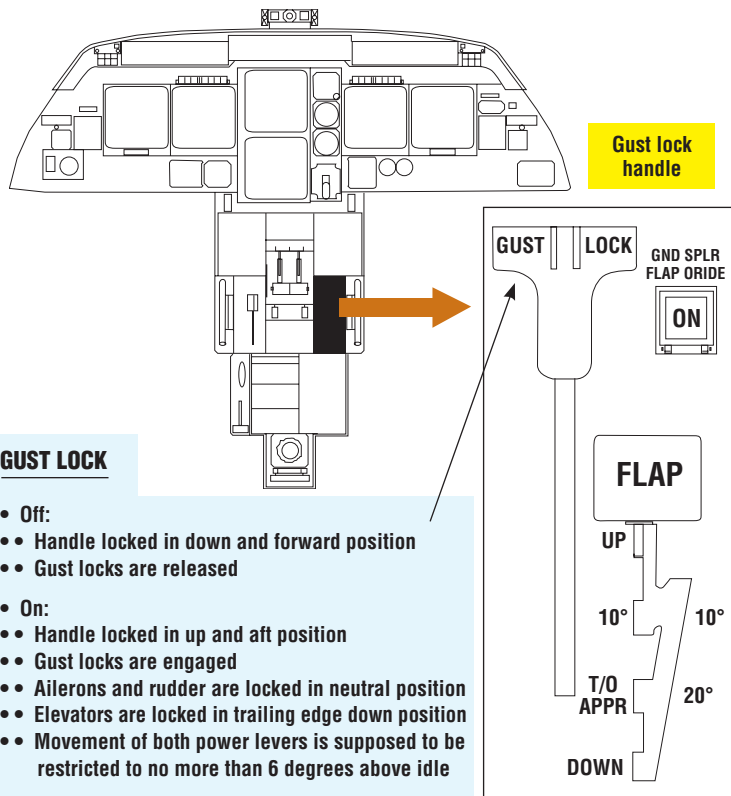
GUST LOCK

Cockpit location diagram of the gust lock itself for the GIV. Gulfstream has redesigned and improved gust lock design for their newer models.
