Comparison of lock-in and pulse-phase thermography for defect characterization in FRP composites applied to concrete

Jeff Brown^a and Sai Harsha Chittineni^b

Dept. of Civil Engineering^a, Embry-Riddle Aeronautical University, Daytona Beach, FL, 32114
Dept. of Aerospace Engineering^b, Embry-Riddle Aeronautical University, Daytona Beach, FL, 32114

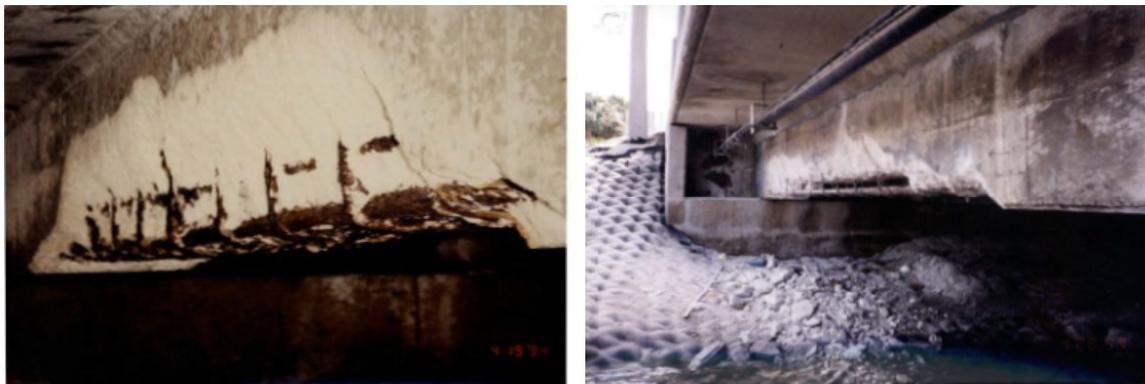
Figure 1. Corrosion damage and 1994 repair of US 192 relief bridge over the Indian River in Brevard County, Florida.

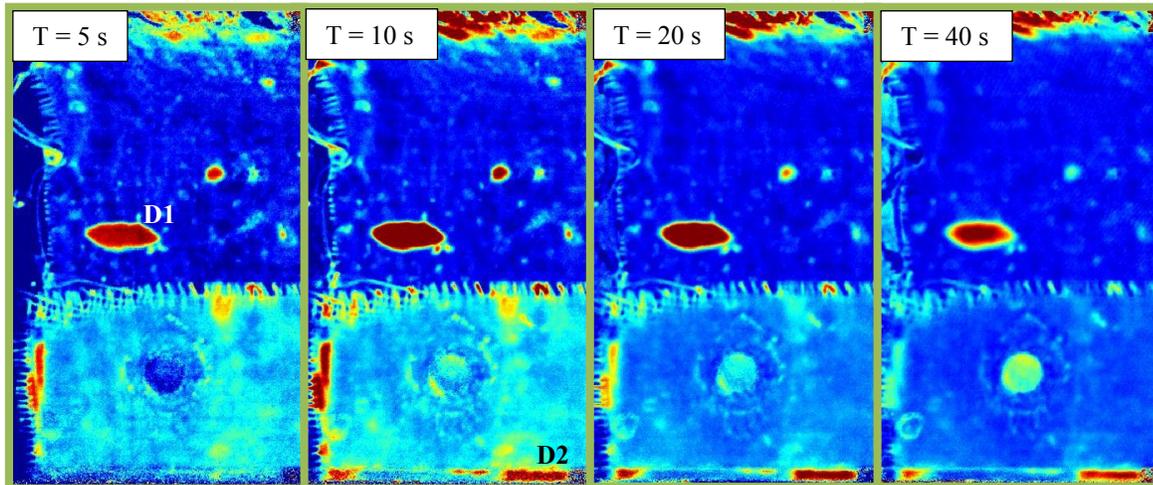
Phase images for Zone 1 are provided in Figure 4. An initial observation is that the overall thickness of the FRP composite varies across the zone. The upper portion of Zone 1 consists of a single layer of woven FRP fabric (0.8 mm thick) while the lower portion consists of two layers. Because the phase response is sensitive to this detail of the FRP system at a period of 5 seconds, it is possible to deduce that any defects first appearing in phase images with $T = 5$ s occur beneath a single layer of FRP. Two defects, D1 and D2, are highlighted for discussion purposes. D1 first appears near the center in the $T = 5$ s image while D2 first appears near the bottom in the $T = 10$ s image. The general conclusion is that D1 lies between one layer of FRP and the concrete substrate while D2 lays beneath two layers of FRP between the composite and the concrete.

Figure 4. Lock-in Phase images for Zone 1 (west side of Beam 1).

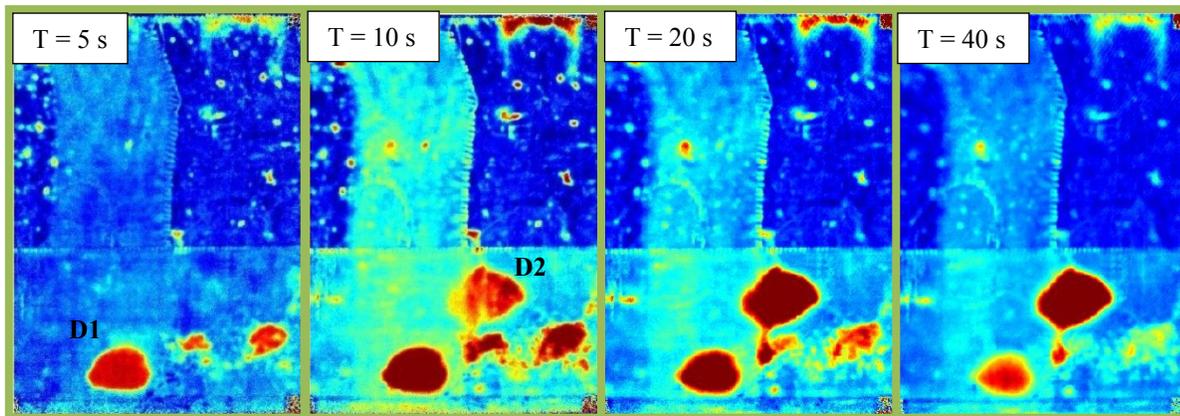
Similar results were obtained for Zone 2 (Figure 5). In addition to the two distinct regions of single and double-layer composite, these images also reveal an overlap shear splice that connects sheets running along the length of the beam. Defect D1 (lower left of $T = 5$ s phase image) occurs between the first and second layer of FRP while Defect D2 occurs under two layers of FRP at the FRP/concrete interface. Another interesting observation is that the peak intensity of the defect signal strength varies as a function of period for defects that occur at different depths. For example, the peak defect signal strength for D1 occurs in the $T = 10$ s image and then decreases as the period increases to 40 s. The defect signal strength for D2 is essentially zero in the $T = 5$ s image and then starts to develop in the $T = 10$ s image. Unlike

D1, the relative intensity of the phase shift with respect to the surrounding area for D2 continues to increase as the period increases to 40 s.

Figure 5. Lock-in Phase images for Zone 2 (west side of Beam 1).

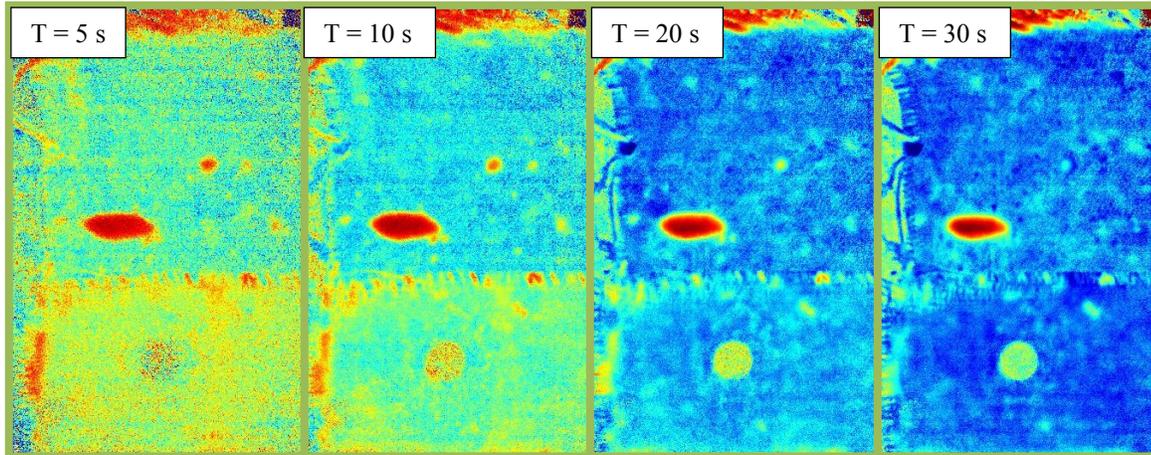
Pulse Phase Thermography results for Zone 1 and Zone 2 are provided in Figure 6 and Figure 7, respectively. In an effort to remain consistent with the results format from the section on lock-in thermography, the frequency values from the DFT output have been converted into their corresponding periods by taking their reciprocals. It is important to note, however, that even though the reported periods are the same, the resulting phase images were obtained through fundamentally different approaches. PPT results for Zone 1 indicate that Defect D1 was detected. Data for Defect D2 was not available due to improper alignment of the IR camera.

Figure 6. Pulse Phase images for Zone 1 (west side of Beam 1). Period, T , is equal to the inverse of the corresponding frequency from the discrete Fourier transform.

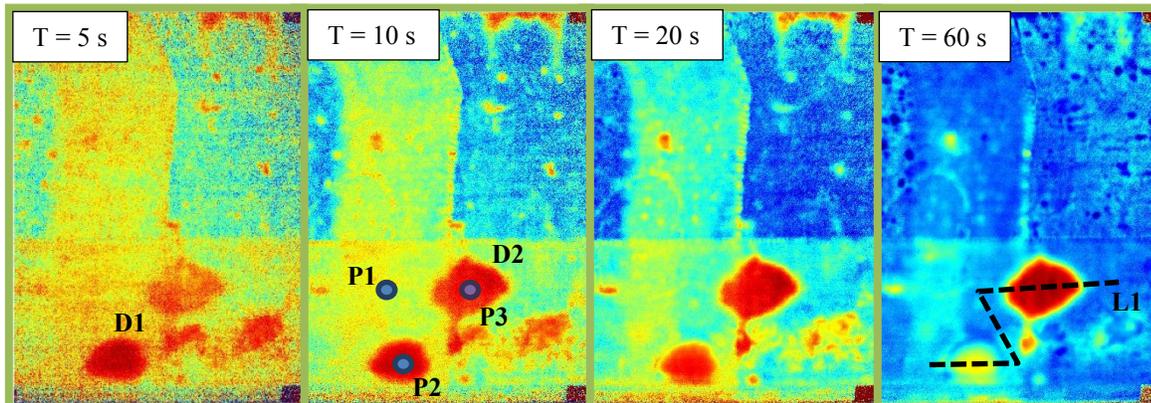
Figure 7. Pulse Phase images for Zone 2 (west side of Beam 1). Period, T , is equal to the inverse of the corresponding frequency from the discrete Fourier transform. Additional data for profile line, L1, and Points P1, P2, and P3 are provided in Figure 8.

Data was obtained for defects that occur at different depths in the FRP system for Zone 2. The defect that was closer to the surface, D1, did appear in the low-period image while the deeper defect, D2, developed a stronger defect signal strength as the period increased. A key observation was that the overall image quality and signal to noise ratio were not as high for the low-period PPT images. The Lock-in Thermography image obtained for $T = 5s$ provided a much clearer image of Defect D1 than the $T = 5s$ PPT image.

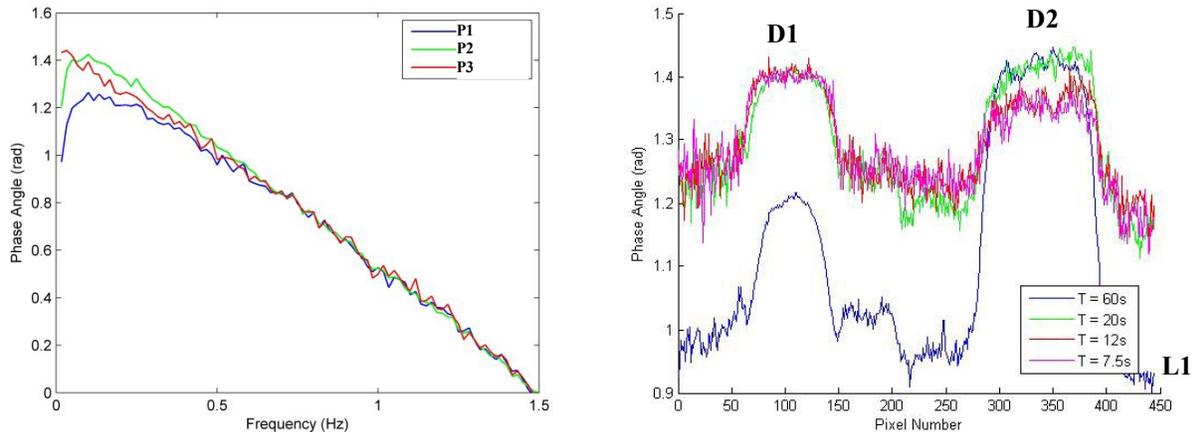
The complete phase angle vs. frequency plot for select points in Zone 2 is provided in Figure 8. Point P1 represents a defect-free region while P2 and P3 were located above Defect D1 and D2, respectively. A common method for extracting defect depth involves first determining the blind frequency, or the frequency at which a defect first appears in the series of phase images. The blind frequency for D1 was estimated to be 0.667 Hz ($T = 1.5s$). The blind frequency

for Defect D2 was more difficult to extract and the defect signal strength appeared to oscillate between frequency values of 0.45 Hz and 0.667 Hz ($T = 2.2$ s to $T = 1.5$ s). This highlights one potential pitfall associated with the PPT method. If the surface heating occurs over a longer period of time, such that defects are already visible in the thermal images at the end of heating, extracting the blind frequency is difficult. It is also necessary to develop a unique model for a specific heat pulse duration that relates blind frequency to depth.

Figure 8. Phase angle data for defect and defect-free regions in Zone 2
