The Spin--an Accident Analysis

Tim Brady
U.S. Air Force, bradyt@erau.edu

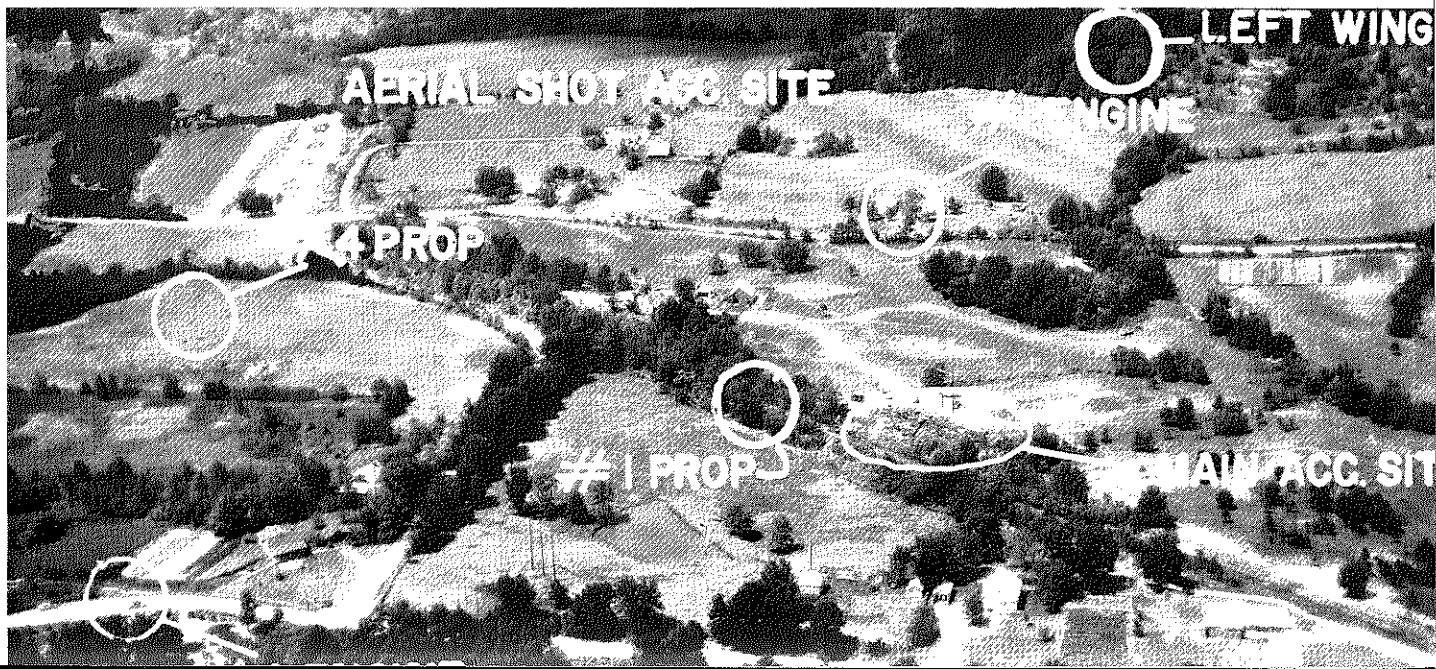
As noted in the accompanying photograph, pieces of the airplane were scattered about a large area, some as much as 4000 feet from the site of the main wreckage. A thirty-foot section of the left wing outboard of the number one engine was found almost 1800 feet from the main site. Number one engine landed very close to a private residence but caused no injuries to the residents. Number four engine and prop landed somewhat away from the main distribution pattern, which indicated that separation from the airplane occurred under high outward centrifugal forces. The right main gear door was found about 1500 feet from the main site with yellow paint markings on the intake aft portion. The paint matched with that of number one prop and further substantiated

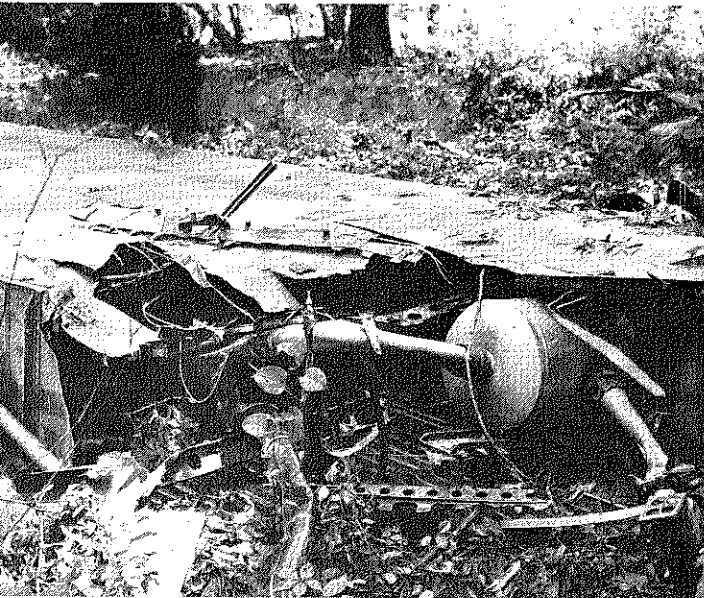
This thirty-foot section of the left wing landed 1800 feet from the site of the main wreckage.

left wing were pulled off and the investigators found that the baffle plates which normally prevent the fuel from sloshing around were forced outward and had sheared loose from their attachments to the lower wing surface and that some of the wing ribs were damaged. This damage was caused prior to separation and was the result of the hydraulic action of fuel pushing against the plates laterally. Without the baffles performing their intended function, the surging fuel had sufficient force to rupture a portion of the lower wing skin near the wing tip, allowing the fuel to spill out. With the integrity of the wing destroyed, it could no longer resist the bending moments

for which it was designed and the greater part of the remaining ribs were broken by wing flex. At that point, wing separation was inevitable.

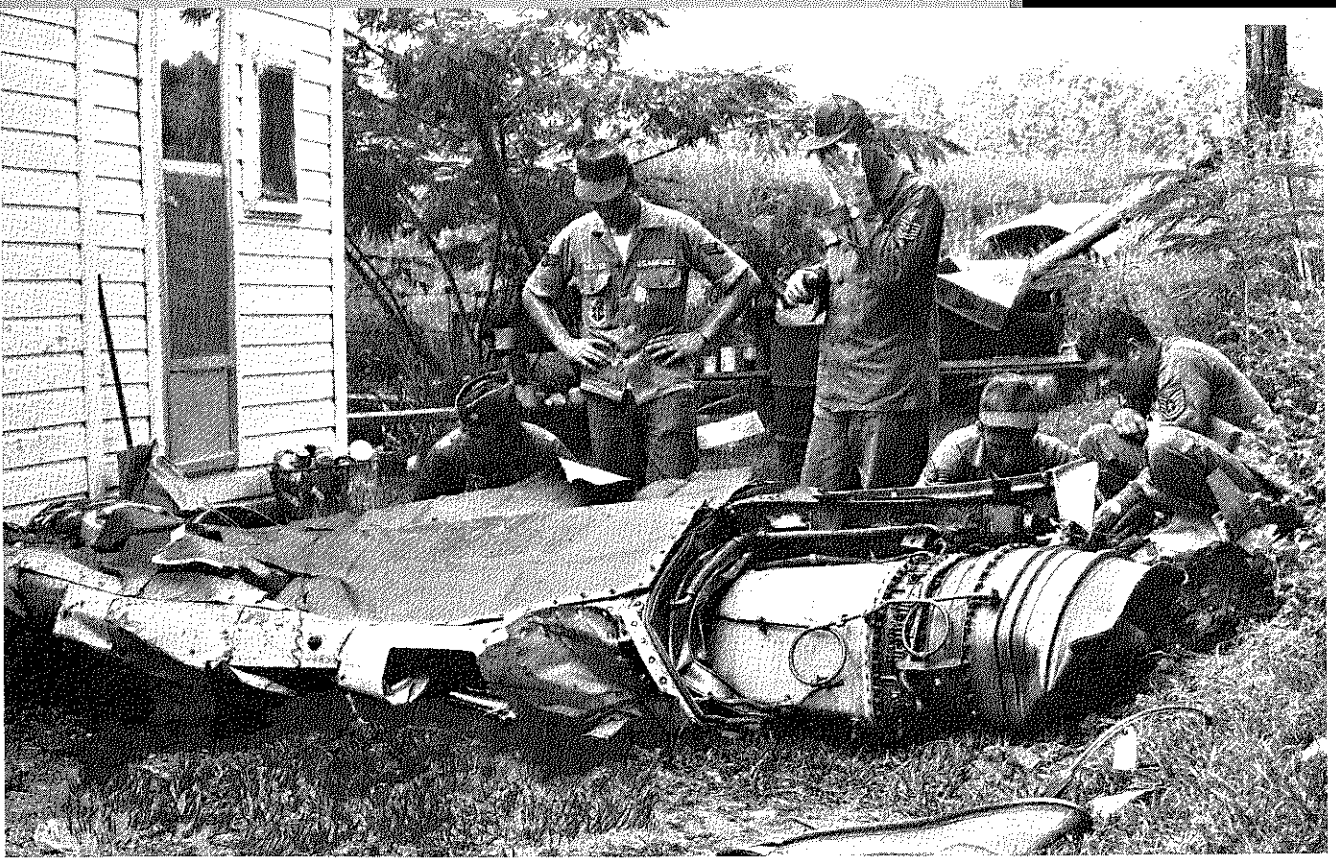
the fact that the airplane was in a very unusual attitude when the number one prop separated. Engines two and three were still attached to the airframe when it hit.

Number one engine landed very close to a private dwelling.

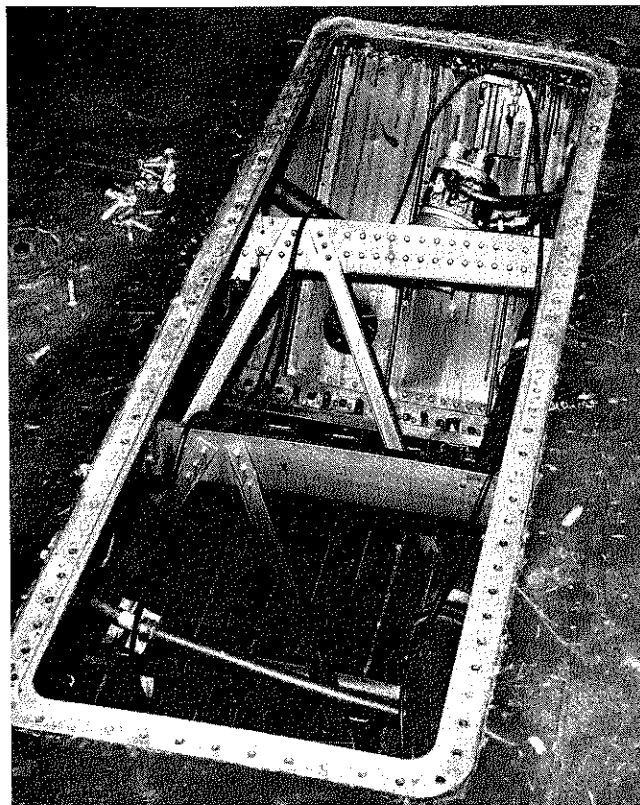
Damage to the fuel tank baffle plates (left wing) was caused by surging fuel.
