Analysis of Causes of Icing Conditions Which Contributed to the Crash of Continental Flight 3407

ANALYSIS OF CAUSES OF ICING CONDITIONS WHICH CONTRIBUTED TO THE CRASH OF CONTINENTAL FLIGHT 3407

P3.3

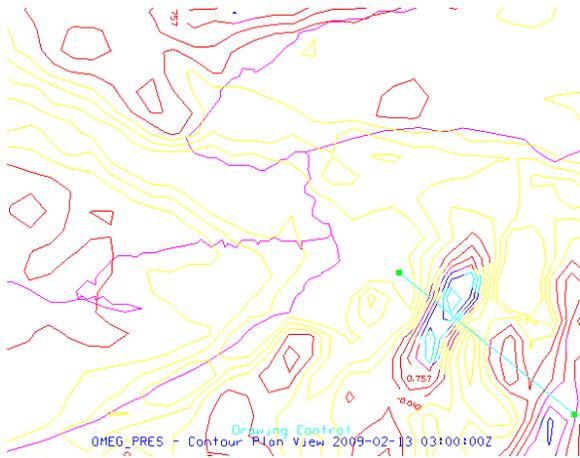
Figure 4. Vertical motion at 850 mb (approximately 4,500 ft.) at 3Z from the WRF model simulation. Straight line is path of Flight 3407.

The enhanced upward vertical motion in western New York was over enhanced terrain. The enhanced vertical motion was persistent in this area during the entire 3 hours of the model simulation. This was also the only area of enhanced vertical motions in western New York which would explain why other aircraft did not encounter the severe icing. If the upward vertical motion in a cloud is faster than the downward fall speed of the droplets, the cloud droplets will be swept upward toward the cloud top where the upward motion stops. This will

cause an accumulation zone of liquid water near the cloud top, which can increase the liquid water content of the cloud. This accumulation zone of liquid water appears to be responsible for the rapid buildup of ice as Flight 3407 descended into the cloud.
