Ergonomics Case Study: EA-6B Prowler Aircraft Maintainer

Alexander G. Pepin, John L. Kleber; Beth Blickensderfer, Ph.D.
Embry-Riddle Aeronautical University

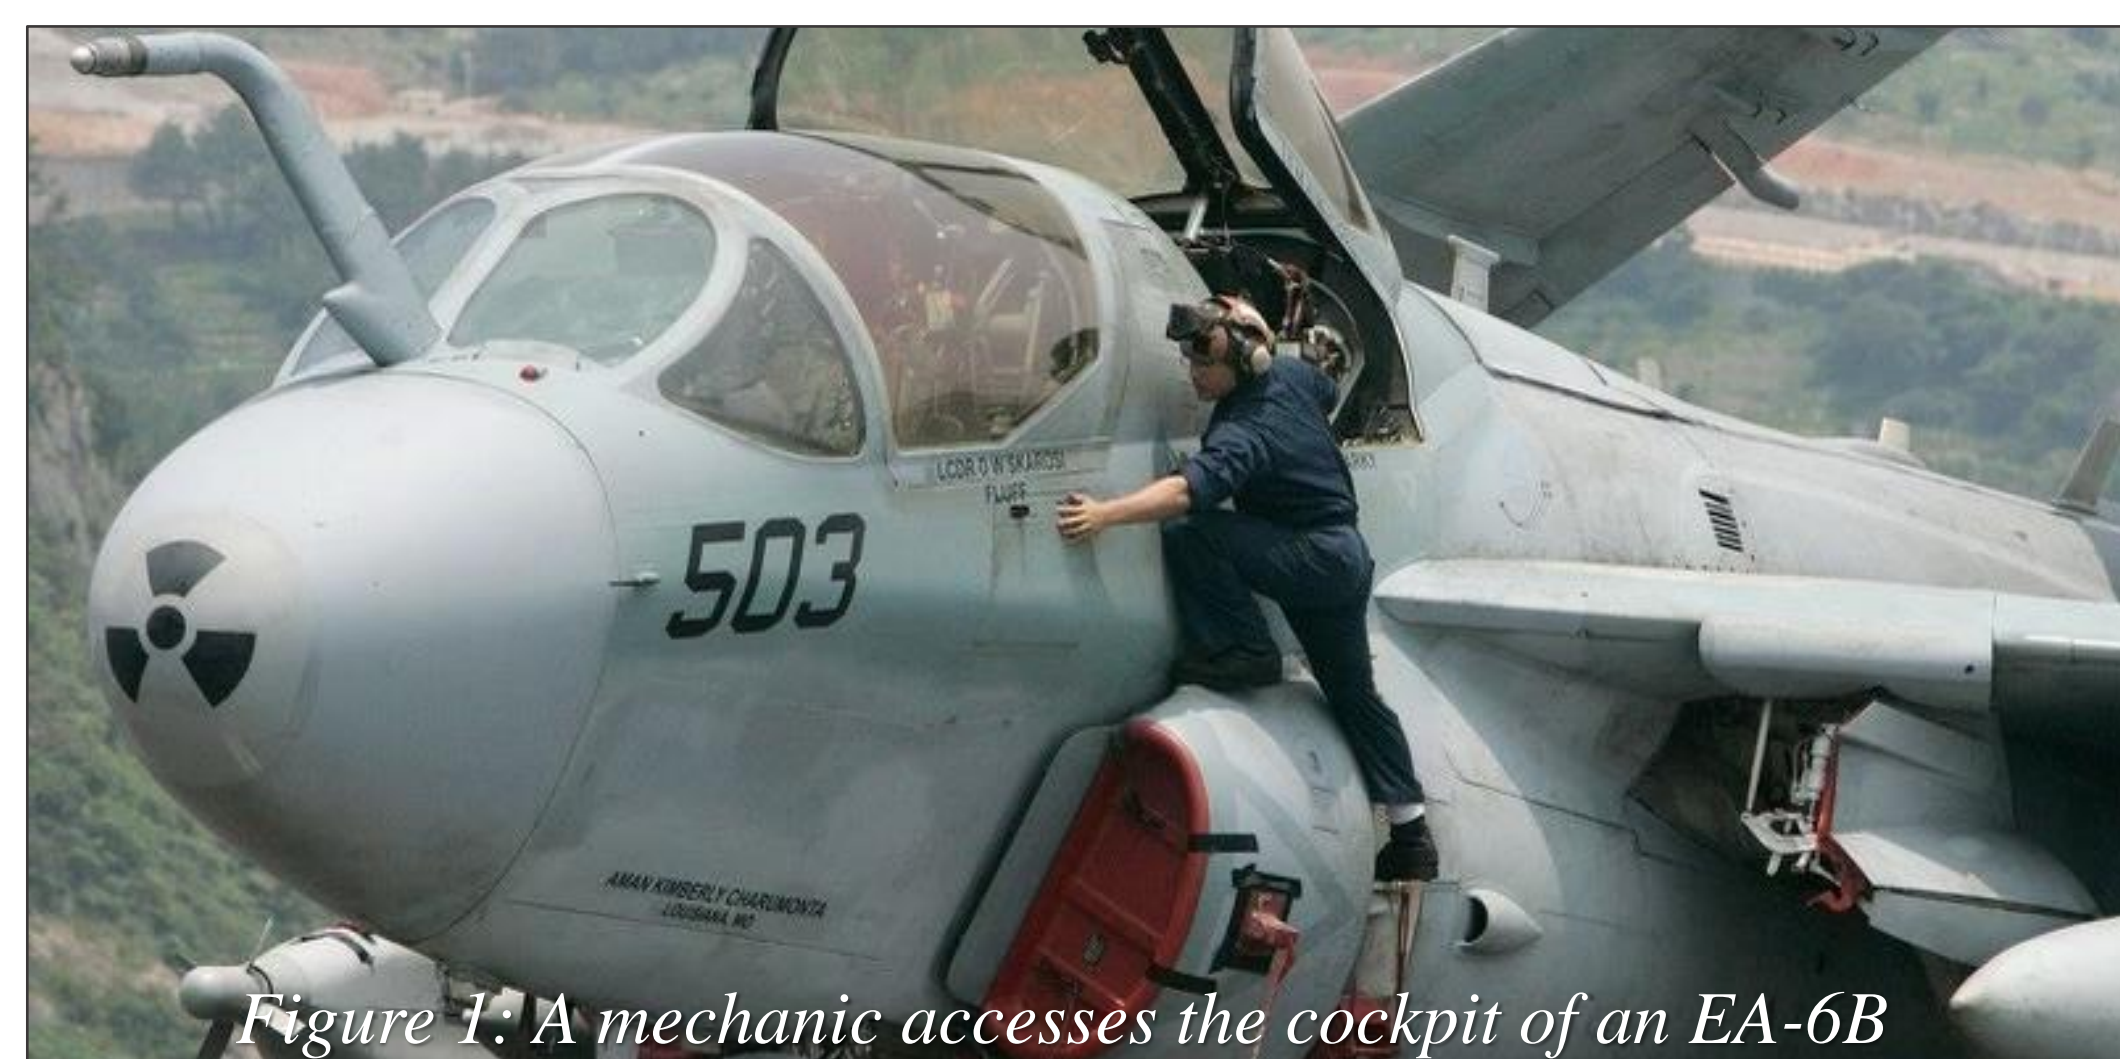
Figure 1. A mechanic accesses the cockpit of an EA-6B

- **Cockpit Preflight inspections**
 - Accessing the four flight stations of the EA-6B forced the participant to assume a variety of awkward postures (Figure 1).
- **Compressor Blade inspections**
 - Lying in the confines of the engine inlet was tiring on the subject's upper back and arms.
 - Rotating the compressor blades significantly strained the participant's wrists and fingers.

- Providing mechanic crews with movable stairwells for rapid & easy access to airplane cockpits.
- Refining & implementing preexisting and less-strenuous borescope compressor blade inspections.
- Reducing door and panel sizes to enable easy handling.
- Using jacks or pulleys to assist in the removal of heavy or awkward objects like the CSD.
