## Filament Winding Composite Airframes for Sounding Rockets

# Filament Winding Composite Airframes for Sounding Rockets

## **Introduction**

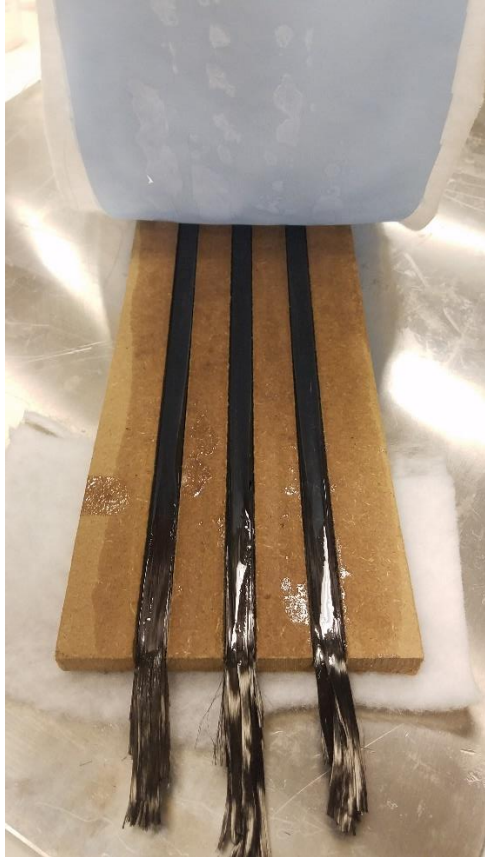
Figure 3: A picture of the carbon fiber coupons in manufacturing prior to vacuum bagging.

The carbon fiber coupon samples were manufactured in a wooden mold and then vacuum bagged. Figure 3 shows the coupons in the manufacturing process just prior to vacuum bagging, and Figure 4 shows three of the samples which were manufactured. These samples did not have a consistent cross-sectional shape, nor did they have consistent fiber distribution throughout the sample. Because of these inconsistencies in the samples the failure of the coupon would not be characteristic of the material strength or stiffness.

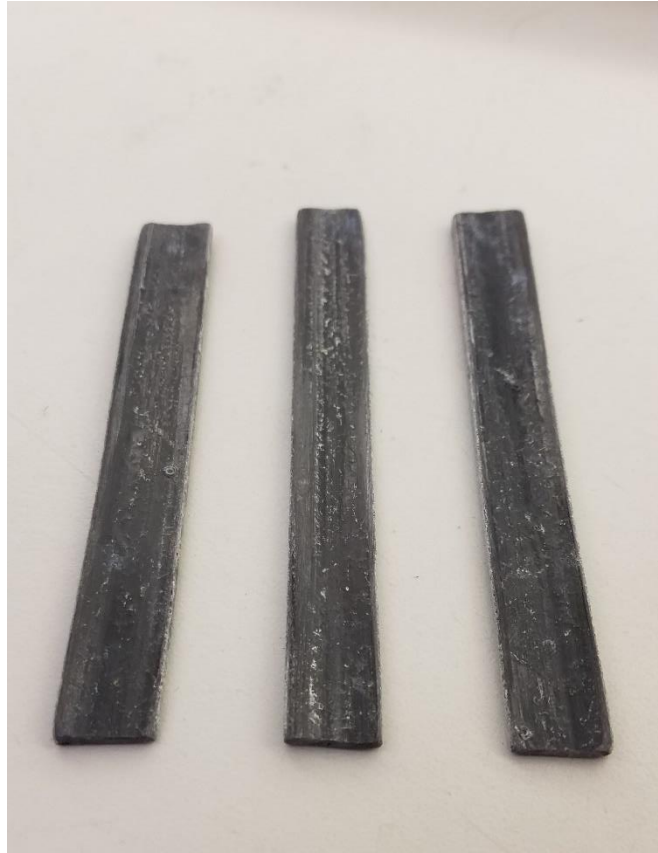
Figure 4: Finished product of carbon fiber coupons cut to length. These were never tested due to poor quality of manufacturing.

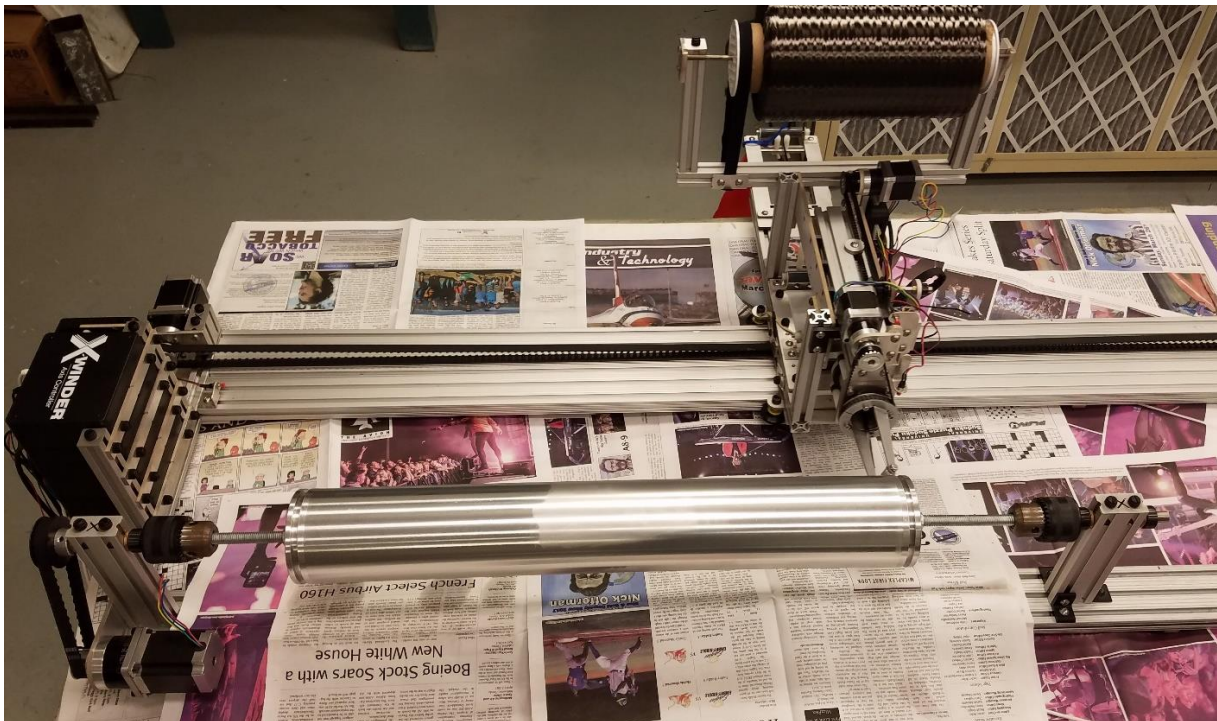
Figure 5: The X-Winder filament winder set up for manufacturing.

The first problem was solved by manufacturing endcaps with a groove on the outer diameter, allowing for a tool to cut the ends of the tube off without damaging the mandrel (see Figure 5). The process involved with removing the ends of the tube was very difficult and time intensive as the cutting groove in the endcaps was not visible after the tube had been wound, so its location had to be approximated. Even after the groove had been cut, removing the end of the tube was still difficult because epoxy would get into the groove, and carbon buildup on the endcaps would encompass the nuts constraining the tool on the threaded rod. Overall the process of removing the mandrel was successful, but very time intensive and difficult.

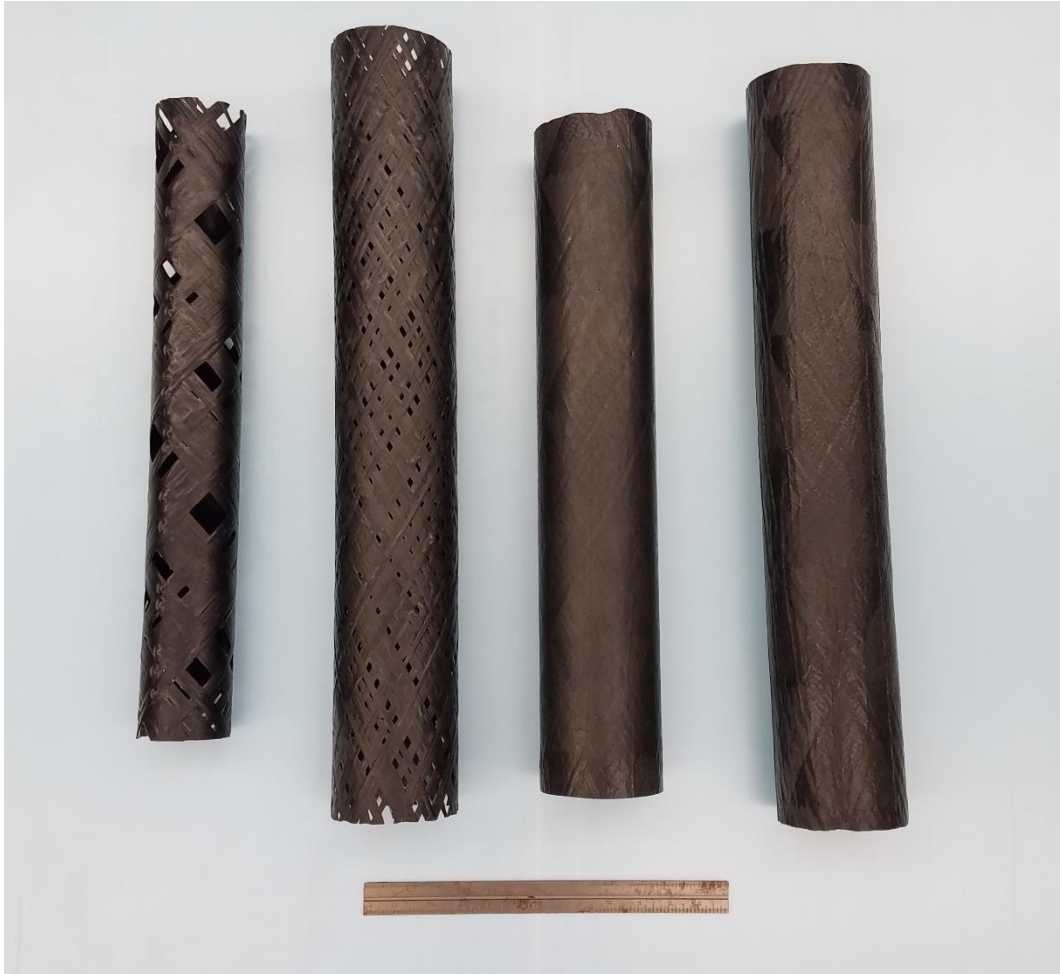
*Figure 6: Tubes are arranged in order of iteration. From left to right: Iteration 1, Iteration 2, Iteration 3, Iteration 4. Iteration 4 was used as the airframe in the flight test. A 12-inch ruler is positioned along the bottom for scale.*

The team ultimately manufactured 4 tubes: 3 iterations of single-layer tubes, and 1 multi-layer tube (see Figure 6). Iteration 1 was manufactured first on a smaller development mandrel and did not finish the winding process because an internal error in the code, the source of which was never identified. Iterations 2 through 4 were manufactured on a larger 4-inch diameter mandrel seen in Figure 5. Iteration 2 had many voids in the single layer. Upon visual inspection of the tube, the primary cause of this was determined to be a difference in thickness of the tow when it is dry and after it had been wetted with epoxy. To account for this, the filament width input in the X-Winder software was changed to the smallest width measured in iteration 2. The results of this change in input resulted in iteration 3. This tube had significantly fewer and much smaller voids, although they were still detectable with a simple visual inspection. Because a majority of the tube did not have voids, the voids that were present were determined to be an effect of either the fiber slipping around an endcap or inconsistencies within X-Winder's code. Iteration 4 was manufactured with the same inputs as iteration 3 with the exception of winding multiple layers instead of 1 layer. There were no visible voids in this iteration and the tube and overall it seemed stiff and rigid. Iteration 4 was used as the structural airframe in the flight test and performed nominally.

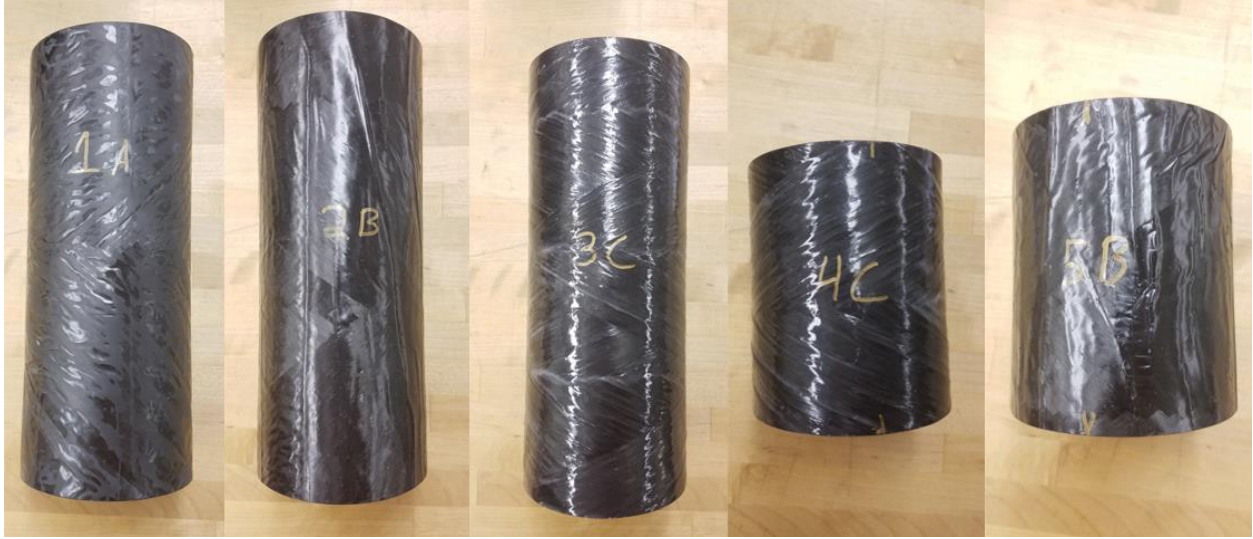
Figure 7: Tubes 1 through 5 prior to testing

Pictures of each tube before and after are included in Figures 7 through 12, while Figure 13 shows a picture of tube 3C in its test configuration just prior to testing.

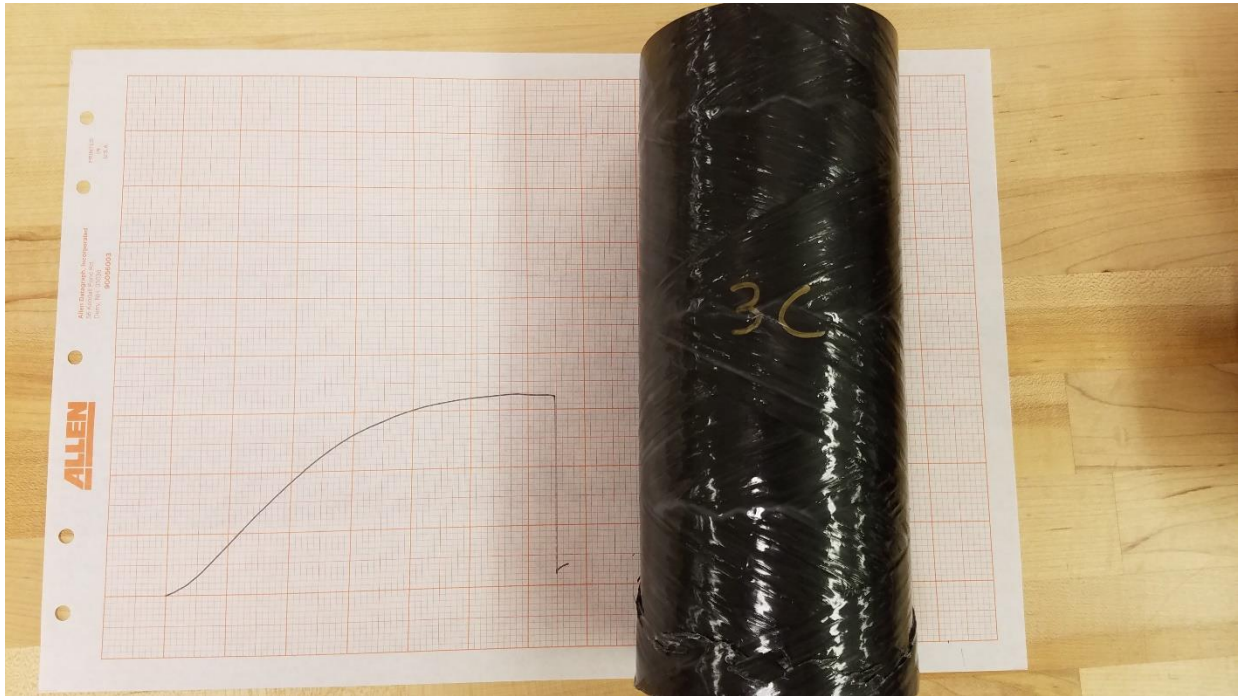
Figure 10: Tube 3C after it had been through its compression test with its Force VS Displacement curve

Test Sample Number	Length (in)	Max Compressive Strength (lbf)	Wind Angle (degrees)
1A	10	10,110	45
2B	10	9,632	55
3C	10	9,816	65
4C	5	10,093	65
5B	5	9,619	55

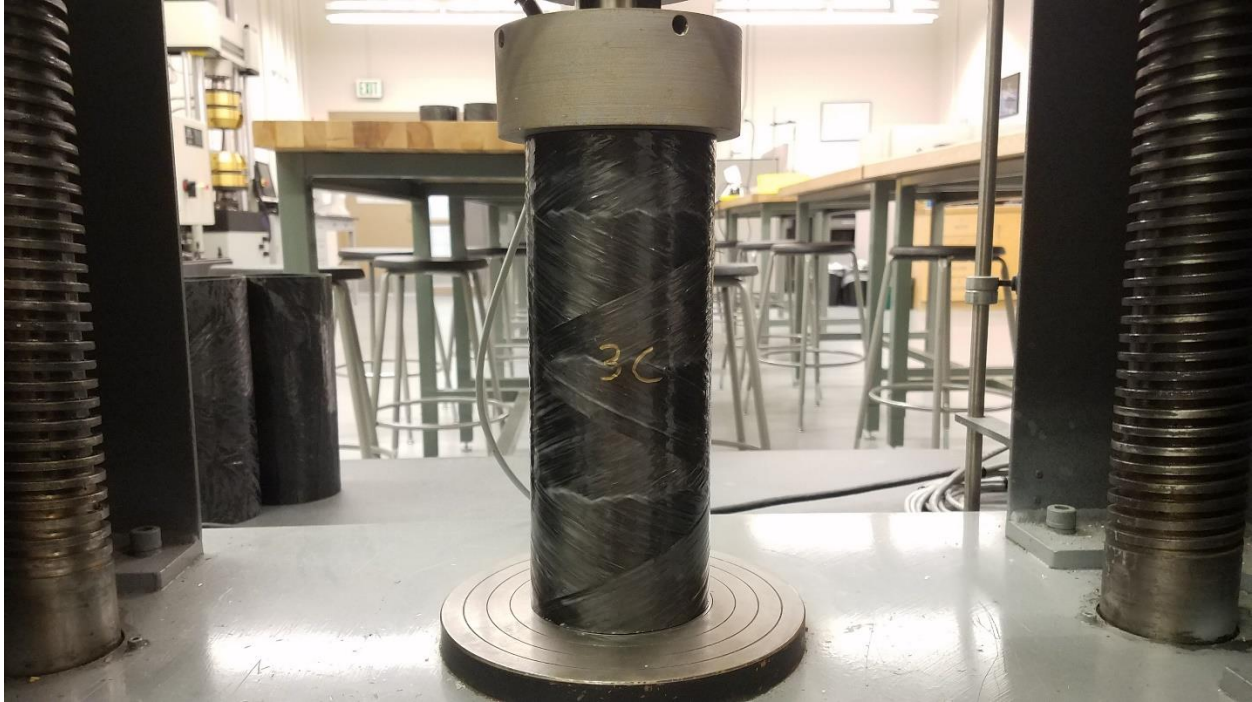
*Figure 13: Tube 3C in its test configuration in the Tinius Olsen LoCap Testing Machine just prior to test.*

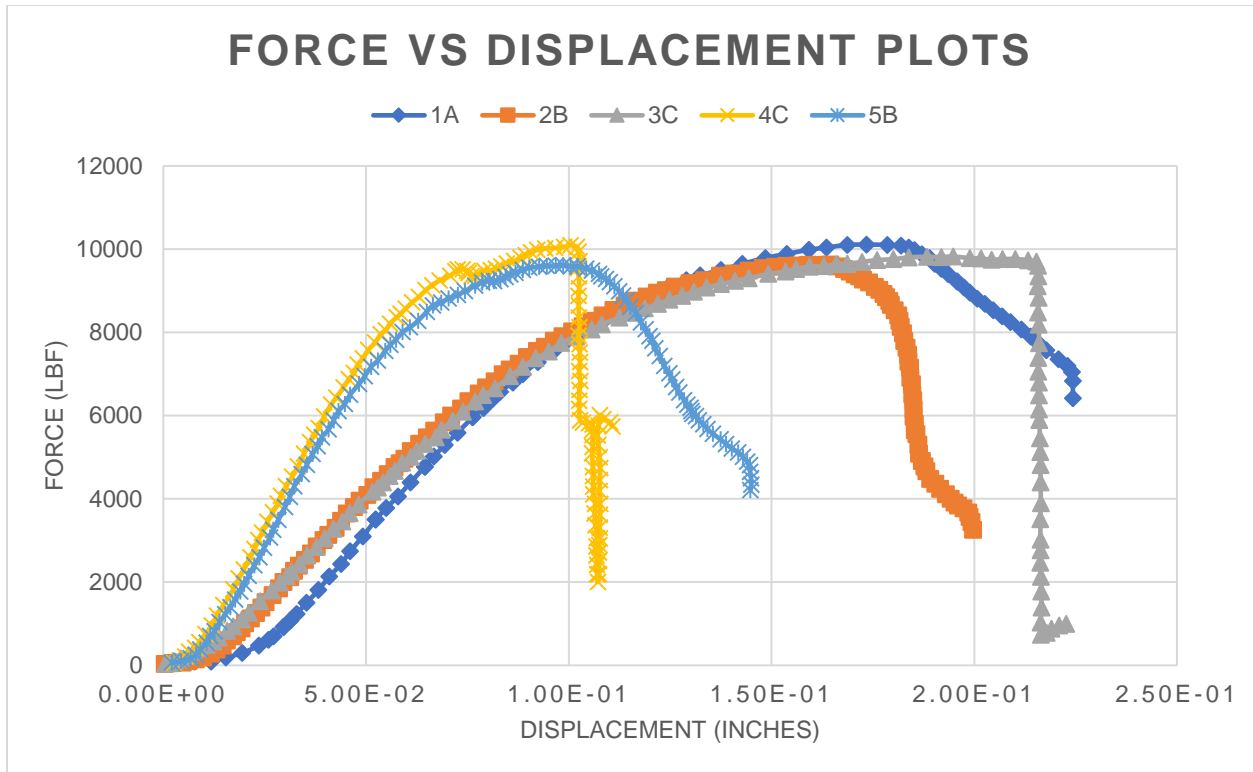
Figure 14: This plot shows the Force VS Displacement data for each of the compression tests.

Each of the plots shown in Figures 7 through 12 were digitized and plotted on top of each other in Figure 14. This showed that the shorter tubes (4C and 5B) had a stiffer reaction than the rest of the longer tubes. Tubes 1A, 2B, and 3C all had approximately the same stiffness despite their differences in wind angle and vacuum bagging. It is important to notice that tubes 3C and 4C both had more brittle failure modes while the rest of the tubes had more ductile failure modes. It is inconclusive whether this was due to the wind angle, the vacuum bagging, or some unknown parameter affecting the failure mode.

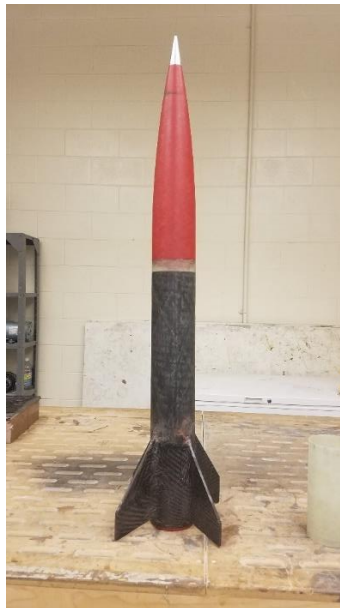
Figure 15: The rocket is fully assembled for pre-flight inspection.

The HIRA demo rocket used the tube produced in iteration 4 of helical winding as the primary structural airframe. The fins were surface mounted to the aft end of the tube, and a commercially purchased thrust plate created a direct load path between the motor and the tube. Figure 15 shows the rocket fully assembled for pre-flight inspection, and Figure 16 shows the rocket on the launch pad.

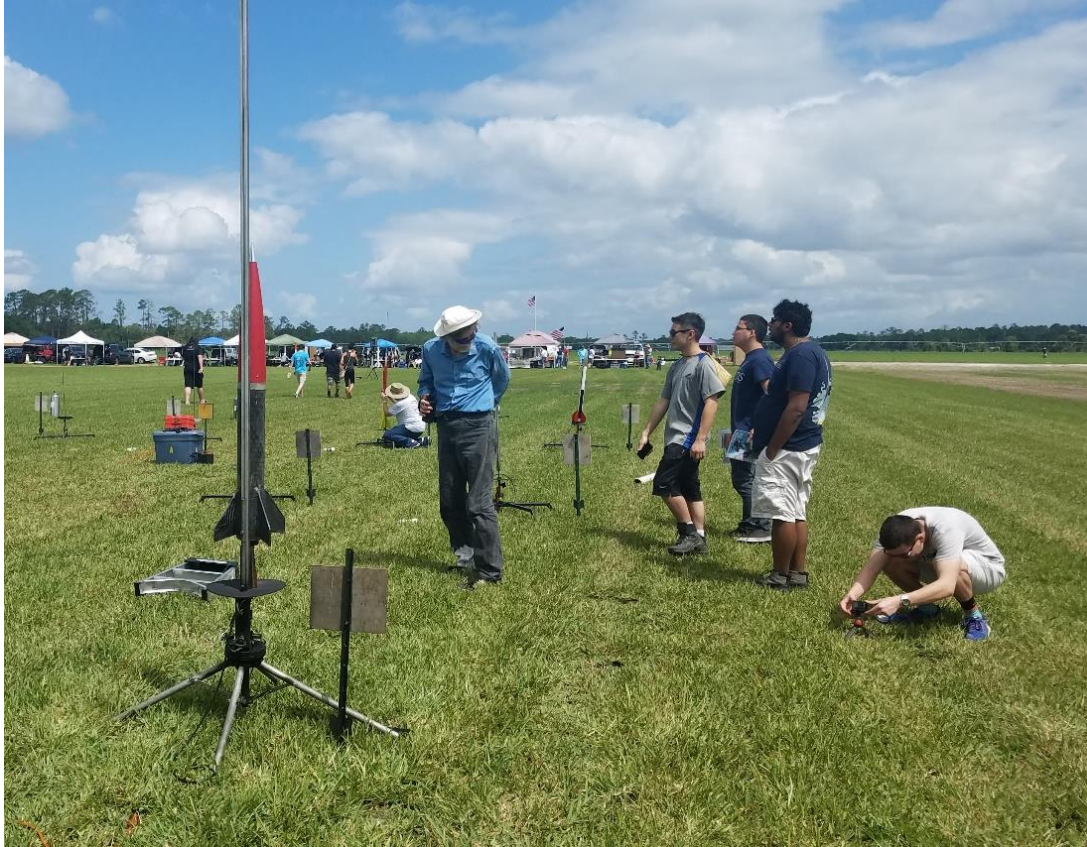
*Figure 16: Team members prepare the rocket for flight on the launch rail. The rocket flew to 4,042 feet above ground level and recovered nominally.*

The rocket flew to 4,042 feet above ground level and recovered nominally. A visual inspection after the flight showed no signs of damage to the tube, and the rocket is considered capable of flying again with no repairs needed.
