## An Evaluation of the Operational Restrictions Imposed to Congonhas Airport by Civil Aviation Instruction 121-1013

Pacheco, Jr., G., Camargo, M., & Halawi, L. (2020). An Evaluation of the Operational Restrictions Imposed to Congonhas Airport by Civil Aviation Instruction 121-1013. *International Journal of Aviation, Aeronautics, and Aerospace*, 7(2). DOI: <https://doi.org/10.58940/2374-6793.1485>

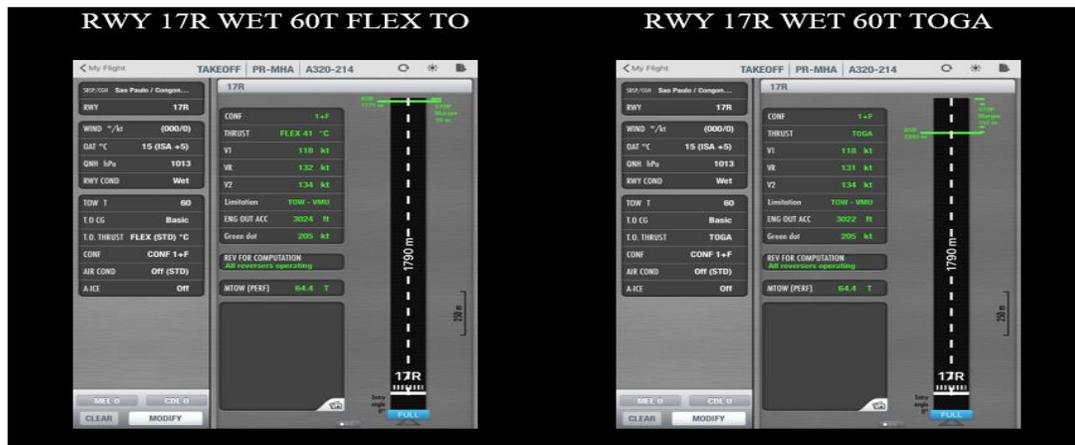
Figure 6. Flex and TOGA setting with the same Takeoff weight.

In Figure 6, the researchers can observe that in aircraft with the same takeoff weight (60T), there is an increase in Accelerating and Stopping Distance (ASD) that results in a reduction in the final margin. An aircraft taking off with a TOGA thrust setting that rejects takeoff at Decision Speed (V1), when stopping the aircraft completely, will have 197 meters ahead. While the aircraft taking off at Flex thrust setting will have 19 meters. The EFB is set to maximize efficiency, therefore taking advantage of the entire runway length, reducing takeoff power as much as possible. Thus, the researchers consider the TOGA setting an unnecessary obligation. The Congonhas auxiliary runway was closed for passenger transportation without any apparent reason. The researchers believe that the auxiliary runway should be available, at least for takeoff operation, as it has a positive impact on air traffic control management. The dispatch limited to 3 tons of EXTRA FUEL is a policy that intends to reduce aircraft landing weight. The problem is that Extra Fuel depends not only on the amount of fuel load but also on the way the flight dispatcher distributed this fuel. Mainly, the planned alternate airport. The same fuel quantity may produce different Extra Fuels depending on the scheduled alternate airport.
