## Redefining Creep: A Comprehensive Analysis of Aviation Accident Survivability

Michael Knott  
Embry-Riddle Aeronautical University  
College of Aviation - Aviation Safety

A Master's Thesis Submitted to the College of Aviation Safety  
in Partial Fulfillment of the Requirements of the Degree of Master  
of Aviation Safety

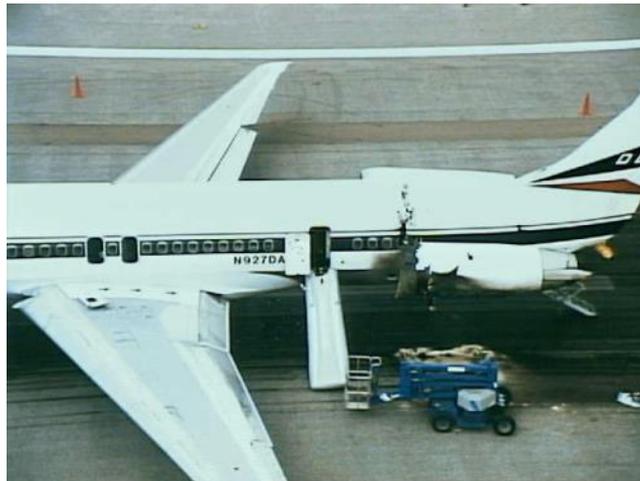
During the aircraft's takeoff roll, the number 1 engine experienced an uncontained failure which resulted in significant damage to the fuselage. Without getting airborne, the crew aborted takeoff and stopped roughly 1400 ft. down the runway. After the aircraft came to rest, the flight crew initiated an emergency evacuation. The accident aircraft can be seen in figure 11; note the damage to the fuselage.

**Figure 11: Damage to MD-88 Fuselage (NTSB, 1997)**

The source of the engine failure was determined to be a fatigue failure of the compressor fan hub which was caused by a manufacturing defect. A drilling process during manufacture created an altered microstructure within the part which went undetected. The altered

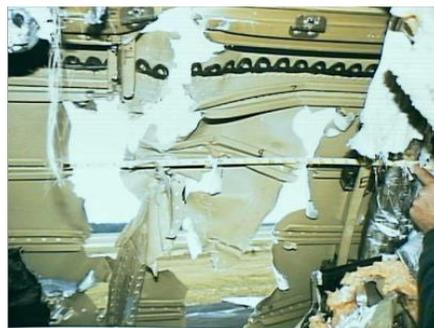
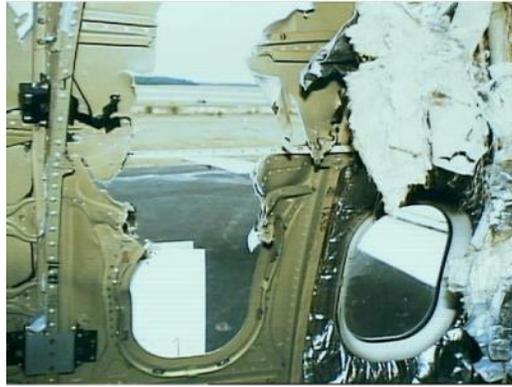
Most of the damage to the fuselage occurred in the proximity of row 37 on the port side of the aircraft. There were roughly four to five separate areas where engine components penetrated the fuselage. Parts of the fan assembly exited the cabin, and a piece of the engine spinner lodged into the ceiling. The damage to the interior of the aircraft can be seen in figures 12 and 13.

**Figure 12: Damage to MD-88 Fuselage at Row 37 (NTSB, 1997)**

**Figure 13: Damage to MD-88 Fuselage at Row 37 (NTSB, 1997)**

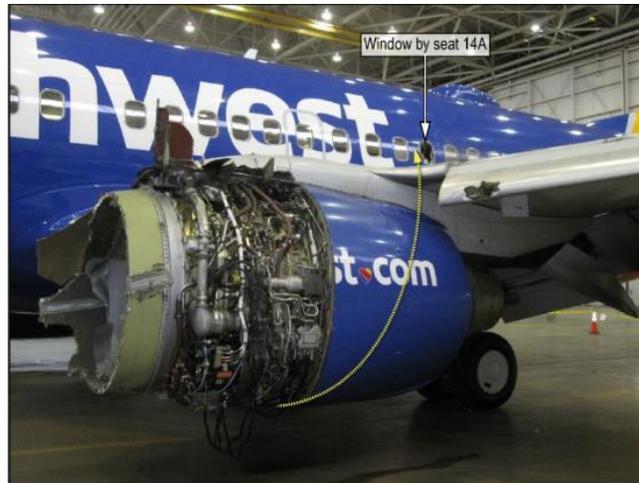
The only fatality was a passenger seated in 14A which was adjacent to the failed cabin window. The window measured 10.5 inches horizontally, 14.375 inches vertically, and 15 inches diagonally. The accident aircraft and cabin window can be seen in figures 14 and 15. Note the location of the failed window in relation to the failed engine cowling.

**Figure 14: Damage to 737 #1 Engine and Cabin Window (NTSB, 2019, p. 78)**

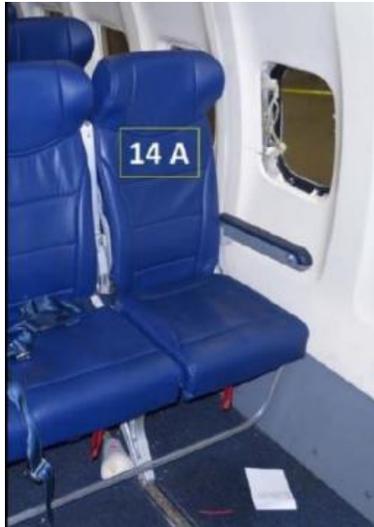
Shortly after the aircraft experienced loss of cabin pressure, flight attendants conducted a walk-through to assist passengers in donning their supplemental oxygen masks. During this process, a flight attendant noticed that the passenger seated in 14A was partially outside the aircraft while still being restrained by her lap belt. The passenger's upper torso, arms, and head were outside the failed cabin window. With assistance from other passengers, the flight attendants were able to bring the passenger back inside the aircraft and initiate cardiopulmonary resuscitation (CPR). The passenger seat in reference to the failed window can be seen in figure 16.

**Figure 16: Cabin Seat 14A** (NTSB, 2018, p. 5)

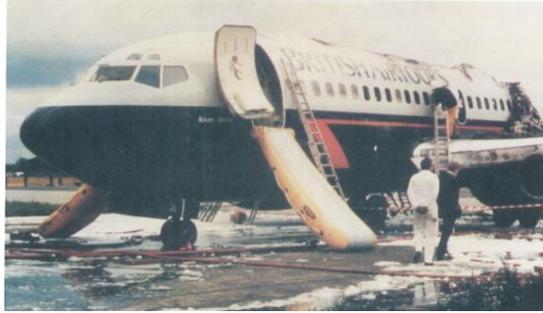
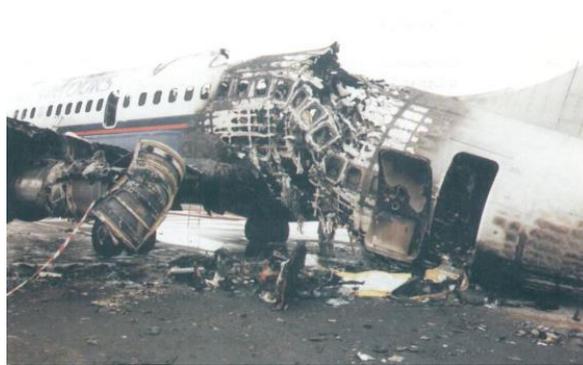
When the aircraft came to rest, the captain stopped the aircraft such that winds from 250 degrees at roughly seven knots, carried the fire onto the fuselage. Shortly after coming to rest, fire and smoke filled the cabin. The aft right side door was opened just prior to the aircraft coming to rest accelerating the rate at which the cabin filled with smoke. Emergency egress was initiated immediately by the crew. The accident aircraft can be seen in figures 17 and 18.

**Figure 17: Boeing 737 Fire Damage** (AAIB, 1989, p. 3)

**Figure 18: Boeing 737 Fire Damage** (AAIB, 1989, p. 3)

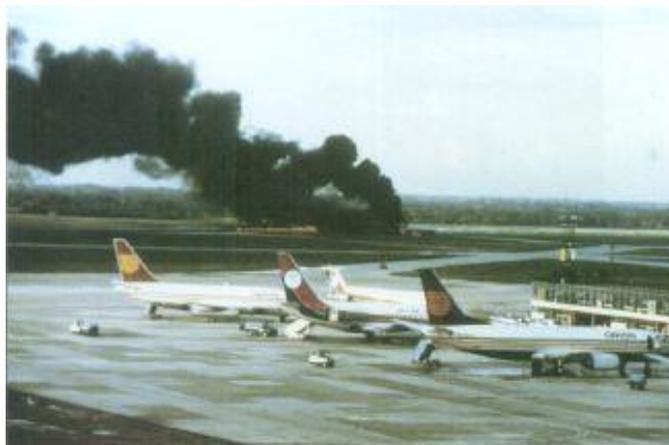
The quantity and chemical makeup of the smoke generated by the fire played a critical role in people's inability to egress the aircraft. Surviving passengers reported that only a breath or two of the smoke burned their throats and made them dizzy. Passengers moved toward escape hatches only to become incapacitated due to smoke exposure. Survivors reported that the forward cabin doors were piled with the bodies of unconscious passengers. Also, the smoke prevented passengers from seeing available egress paths by masking visual cues. Figure 20 shows the thick black smoke billowing from the aircraft seen from a distance.

**Figure 20: Smoke from Flight 28M** (AAIB, 1989, Appendix 4 fig e)

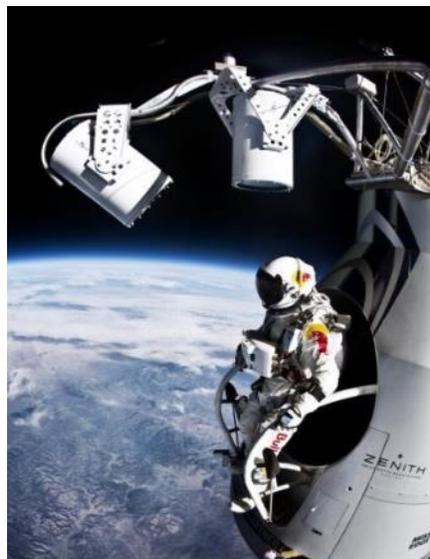
**Figure 21: Red Bull Stratos Jump (Red Bull, 2020)**

The Red Bull Stratos Project was a flight test program privately funded by the company Red Bull and carried out between 2005 and 2012. The project involved parachutist Felix Baumgartner jumping from both aircraft and helium filled balloons from varying altitudes. On October 14, 2012, the program culminated in Felix jumping from an altitude of 127,852 ft. and achieved a maximum speed of 843.6 mph (Mach 1.25) during his descent. The program broke the world records for the highest manned balloon ascent of 128,178 ft., the highest jump altitude, and the maximum vertical speed achieved by someone in freefall. Felix was the first person to exceed the speed of sound in freefall without the protection or propulsion of a vehicle. Figure 21 shows the parachutist just prior to jumping from the capsule.

The program included jumps from aircraft at an altitude of 27,000 ft. to test the pressure suit and physiological monitoring systems. The testing also included jumps from helium balloons from altitudes of 71,581, 96,640, and 127,852 ft. The program collected both medical and scientific data throughout the flight test program. The Stratos Project shared some similarities with the U.S. Air Force Project Excelsior, which took place in late 1959 and 1960. Project Excelsior involved Colonel Joseph Kittinger jumping from helium balloons from altitudes of 76,400, 74,700, and 102,800 ft. Joe Kittinger would serve on the Stratos Project under flight operations and safety where he was responsible for all communications with Felix during jumps throughout the program (Red Bull, 2020) (Jenkins, 2012).

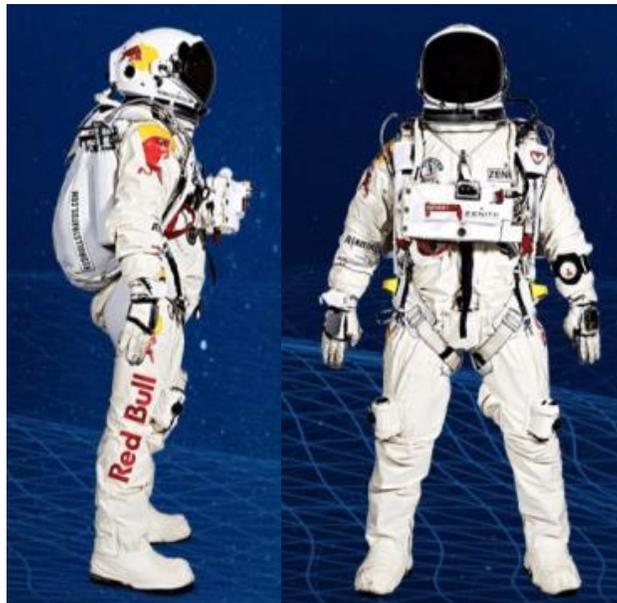
al, 2014). All of the physiological monitoring systems were integrated into the pressure suit which can be seen in figure 22.

**Figure 22: Pressure Suit Worn by Felix Baumgartner (Red Bull, 2020)**

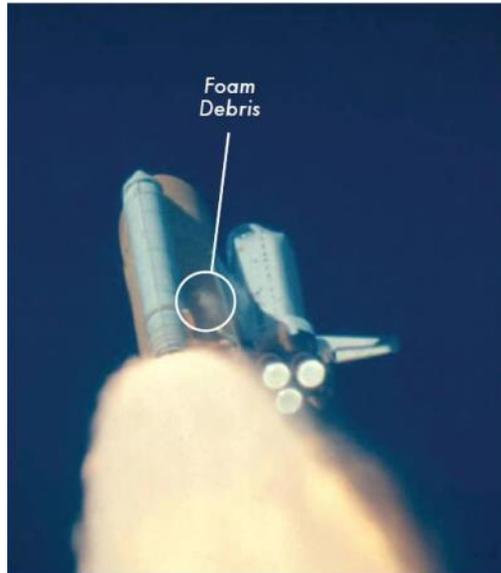
The cause of the breakup was determined to be failure of critical structure on the orbiter's left wing during atmospheric reentry. During the shuttle launch 16 days earlier, a piece of insulating foam from the shuttle's main external tank broke away and struck the orbiter. Photograph and video analysis showed the piece of foam, roughly 21 to 27 inches long and 12 to 18 inches wide, striking the orbiter at a relative velocity of between 416 to 573 mph. The foam struck the leading edge of the left wing damaging the wing's thermal protection system. Figure 23 shows the foam strike during launch (NASA, 2003).

**Figure 23: Insulating Foam Strike from STS-107** (NASA, 2003, p. 34)

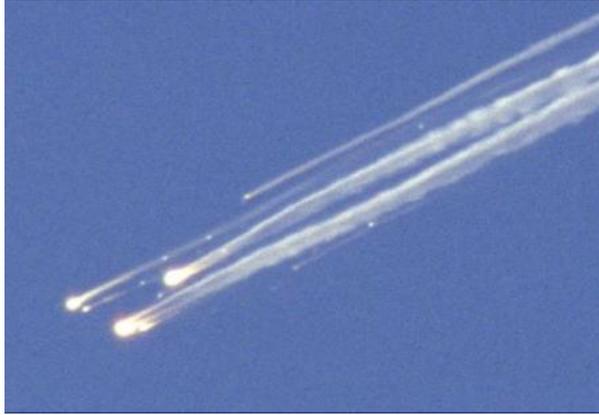
The damaged thermal protection system allowed superheated gas to penetrate the wing which ultimately caused the aluminum wing structure to fail. Once the left wing failed, the orbiter started to roll, pitch, and yaw uncontrollably. The loss of control exposed the aircraft to excessive aerodynamic forces which ultimately caused it to break up in flight. Figure 24 shows the orbiter from the ground streaking across the sky over the state of Texas in multiple pieces (NASA, 2003) (NASA, 2014).

**Figure 24: STS-107 on Re-Entry** (NASA, 2003, p. 41)

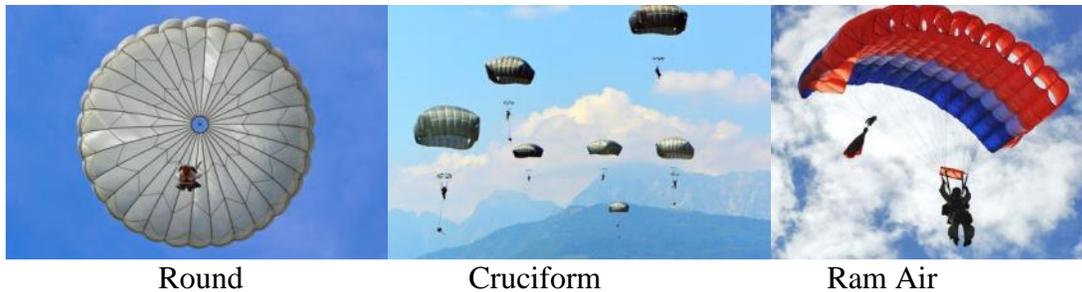
Today, parachutes are used for a variety of reasons to include airdropping military assets, providing a safe means of escape for aircrew in the event of an emergency, as well as used in the sports of base jumping and skydiving. There are many types of parachutes in use today and they mostly vary by the type of canopy used. The three most common types are round, cruciform, and ram air. Round parachutes are the simplest design, were the first to be used, and tend to be the hardest to control. Cruciform parachutes use a square shaped canopy, can decrease landing speeds compared to round parachutes, and can reduce oscillations experienced during descent. Ram air parachutes are highly controllable, highly maneuverable parachutes whose canopy creates an airfoil when inflated. By flaring or stalling a ram air parachute during landing, landing speeds can be very low. Figure 31 shows the three types of parachutes (What Parachute Types Are There, 2019).

**Figure 31: Types of Parachutes** (What Parachute Types Are There, 2019)

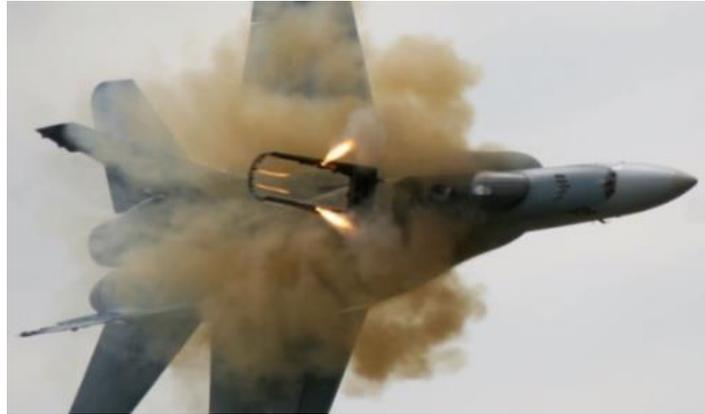
create a clear path for egress, the canopy/hatch is either jettisoned or explosively fractured. The purpose of getting rid of the canopy/hatch is to allow the aviator to escape without contacting the aircraft thereby reducing the risk of injury. In some systems, canopies/hatches are jettisoned using ballistic and rocket charges while others use explosives for fracturing. Figure 33 shows the canopy of a CF-18 being jettisoned immediately after the initiation of an ejection.

**Figure 33: CF-18 Canopy Jettison** (Copp et. al, 2015)

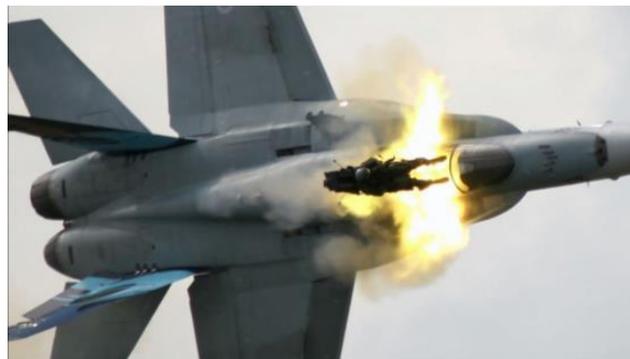
In the case of aircraft with multiple crew, the aircraft separation phase is executed in a predetermined sequence at slightly different directions. To prevent the risk of midair collisions of occupants seated in their ejection seats, aircraft with multiple ejection seats do not fire all of the seats simultaneously. The ejection seats will fire at different times and in different directions to ensure that safe separation is maintained between the multiple ejection seats once separated from the aircraft. Due to the longer time needed to egress multiple crew members, the safe escape envelope will be impacted when compared to a single seat aircraft (N. Schombs, personal communication, August 19, 2020). Figure 34 shows the aircraft separation phase from a CF-18.

**Figure 34: CF-18 Aircraft Separation** (Copp et. al, 2015)

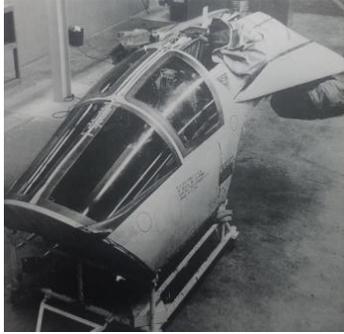
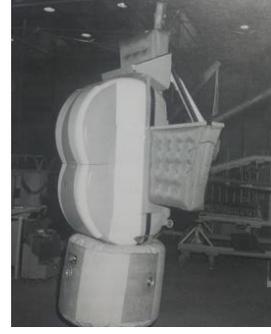
Supersonic bombers such as the B-58, and the XB-70A used fully encapsulated ejection seats while the supersonic fighter, the F-111 used a crew escape module (Tuttle, 2002). The Mercury and Apollo spacecraft had launch escape systems for early rocket failures while the SpaceX Crew Dragon capsule has an emergency escape function which can operate for the entire ascent phase of the mission in the case of failure (Reisman, 2015). Figure 36 shows examples of encapsulated seats and crew escape modules.

F-111 Crew Escape Module

XB-70 Encapsulated Ejection Seat
