Paper Session I-A - Space-Based Telemetry And Range Safety Flight Demonstration 1

Section 1A Technologies for Future Spaceports and Ranges Space-Based Telemetry And Range Safety Flight Demonstration 1

Space-Based Telemetry And Range Safety Flight Demonstration #1

Prepared for
41st Space Congress
April 27, 2004

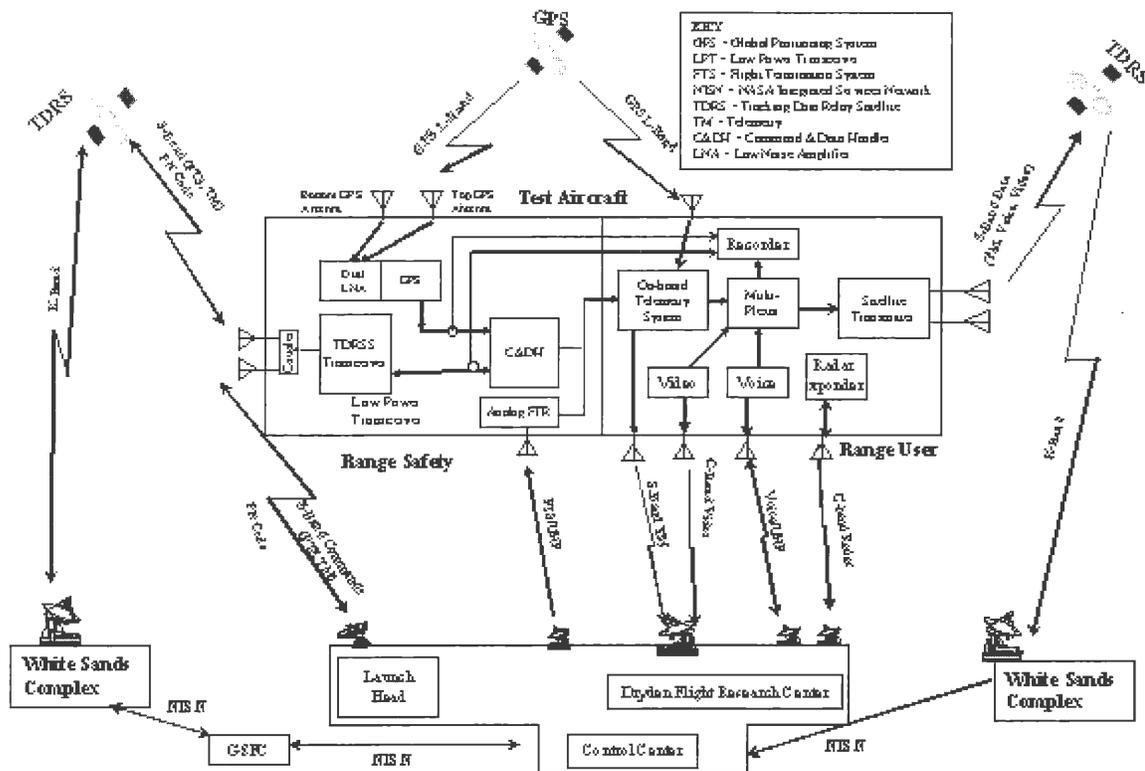
STARS is composed of two major systems: the Range Safety and Range User systems (Figure 1). The Range Safety system used for Flight Demonstration #1 (FD#1) included a new, versatile, low-power transceiver (LPT) with multichannel capabilities coupled with a custom-built command and data handler (C&DH) flight processor and a commercial Ashtech Z-12 C/A code Global Positioning System (GPS) receiver. The LPT received a four-channel 400-bps flight termination system (FTS) link and transmitted telemetry data at 10 kbps, containing tracking data and health and status indicators for the Range Safety system. The Range User system used broadband communications (125 kbps to 500 kbps) for voice, video, and vehicle/payload data. The launch-head command link used radar data to dynamically attenuate the transmitted signal in an attempt to have constant power at the STARS receive antenna input. NASA's Tracking and Data Relay Satellite System (TDRSS) was the space communications link.

Figure 1. The STARS System for Flight Demonstration #1

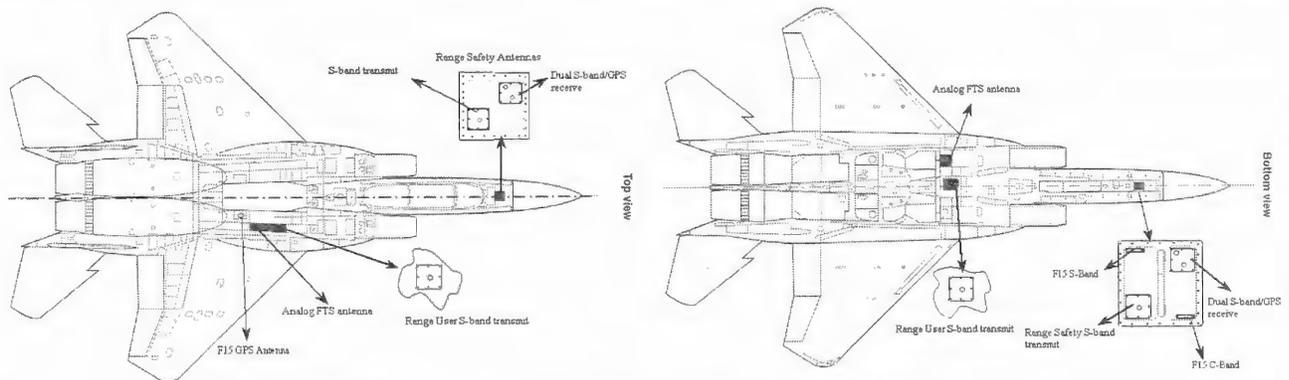
The locations of the STARS antennas on the aircraft are shown in Figure 2. The Range Safety system used four S-band antennas (~ 4 inches square by 3/8 inches thick) designed and fabricated by Physical Science Laboratories (PSL). There were two antennas on the top of the aircraft and two on the bottom of the aircraft. Each set contained one dual-element antenna for receiving TDRSS/launch-head and GPS signals and another single-element antenna for transmitting to TDRSS/launch-head. The centers of the Range Safety antennas were a few inches off the aircraft's centerline. The top Range Safety transmit antennas were about 27 inches forward of the bottom Range Safety antennas and canted from the horizontal due to the shape of the fuselage.

The Range User system used two transmit-only antennas identical to the Range Safety transmit antennas except for being tuned for different frequencies. One single-element antenna was on the top of the aircraft and another one was on the bottom of the aircraft. The center of the top Range User antenna was about 10 inches forward of the bottom antenna and 48 inches to the right of the aircraft's centerline. The bottom Range User antenna was 3.5 inches to the right of the aircraft's centerline.

Figure 2. Antenna Locations on the F-15B

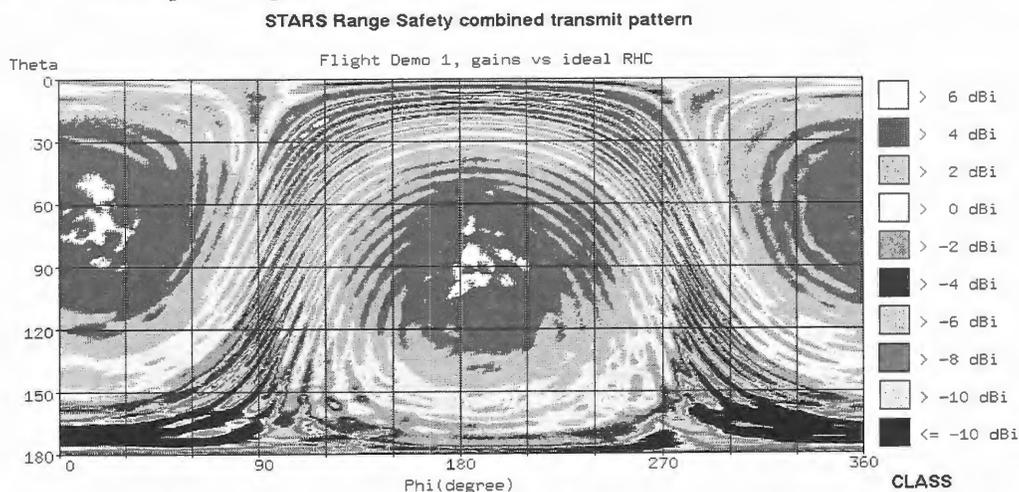
The Communications Link Analysis and Simulation System (CLASS) Antenna Radiation Pattern Analysis Tool (ARPAT) used a three-dimensional (3-D) F-15 model and the patterns of the PSL antennas to estimate the composite patterns for FD#1. The predicted patterns considered the effects of the mounting on the F-15, the aircraft shape, and interferometer effects. The combined Range Safety transmit pattern is shown in Figure 3. Theta is in the plane dividing the aircraft into right and left halves: 0° at the nose, 90° straight up from the aircraft, and 180° at the tail. Phi is in a plane perpendicular to the longitudinal axis of the aircraft: 0° straight up from the aircraft, 90° out the starboard wing, 180° straight down, and 270° out the port wing.

Figure 3. Range Safety Combined Transmit Pattern

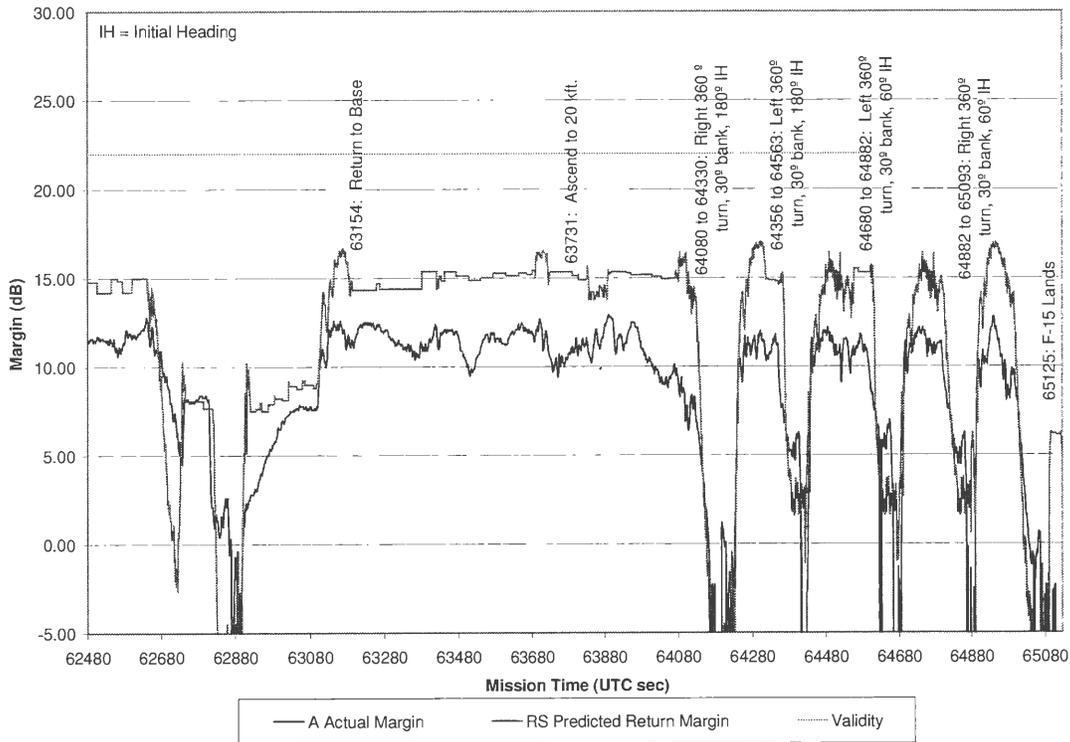
Figure 4 and Figure 5 show the actual and predicted link margins versus time for the Range Safety TDRSS telemetry link during portions of Flights 6 and 7. These plots were chosen because they represent the performance of the Range Safety telemetry system after the additional power filtering was added for the HPAs. The STARS Final Report contains nearly 100 such plots for all the different link margins.

Note that the predicted values generally follow the actuals quite well, indicating that the attitude and trajectory data correlates well with the prediction models. The differences between the predicted and actuals are only 1 to 2 dB for Flight 6 and about 7 dB for Flight 7. The differences for Flights 1 to 5 were about 8 to 10 dB, with actuals being about 5 dB.

Figure 4. Flight 6 RS Telemetry Link Margins

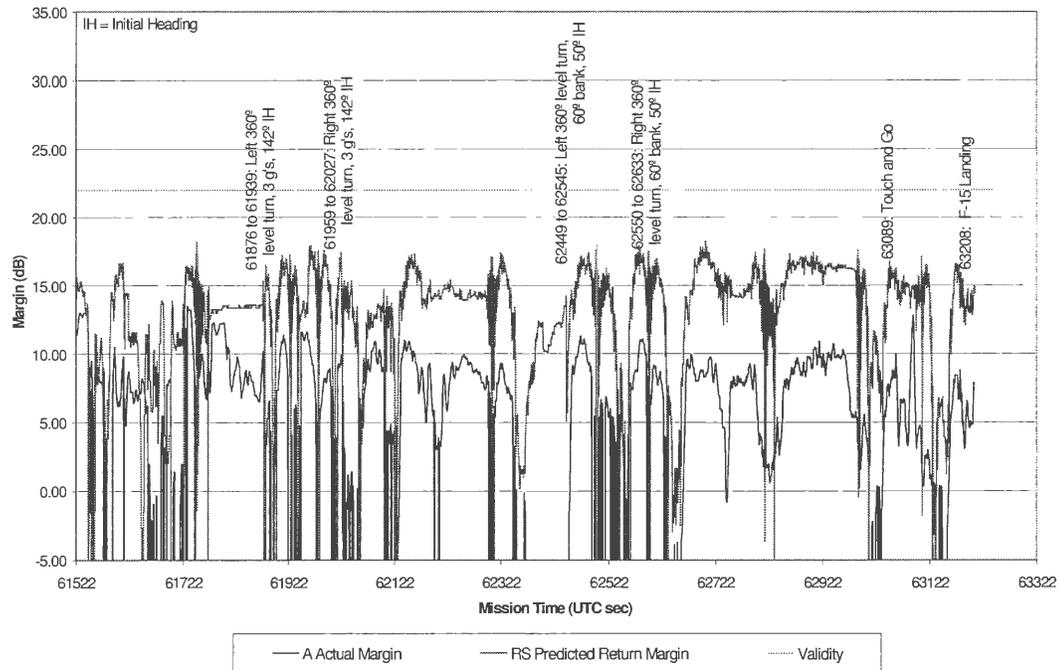
Figure 5. Flight 7 RS Telemetry Link Margins

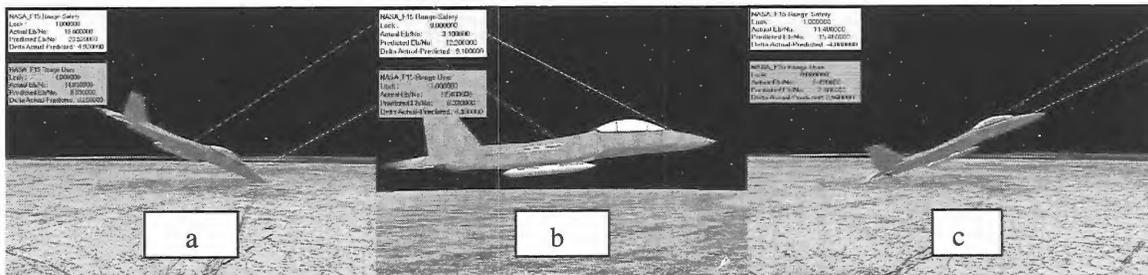
After the PRIMES testing was completed, additional STK simulations were performed to illustrate the blockage caused by the cockpit canopy. Figure 6 shows snapshots from Flight 7, which used TDRS-W for the Range User system and TDRS-171 for the Range Safety system. These pictures show vectors from the top antennas to the respective TDRSS satellites. Note that these are only vectors and not the full antenna pattern. Recall that the Range User antenna was located in the midsection of the aircraft and the Range Safety antenna was located on the nose of the aircraft.

Figure 6. No Blockage of Range User or Range Safety Links

In Figure 6a, there was no blockage of either the Range User or Range Safety links. In Figure 6b, there was no blockage of the Range User link, but the Range Safety link was blocked by the cockpit canopy. In Figure 6c, there was no blockage of the Range Safety link, but the Range User link was blocked by the cockpit canopy.
