Application of Cold Spray Technology in Aviation Industry

Dr. Koh Pak Keng

ECK Pte Ltd

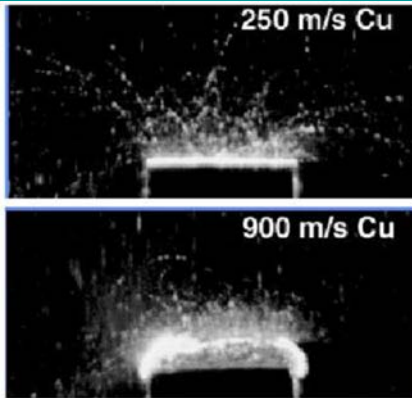
Particle velocity (V_p) < critical velocity (V_c) solid particle erosion of surface

Particle velocity (V_p) > critical velocity (V_c) particles plastically deform and adhere to the substrate

High velocity impact disrupts the oxide films on the particle and substrate surfaces, pressing their atomic structures into intimate contact with one another under momentarily high interfacial pressure and temperature [Karthikeyan, 2004].

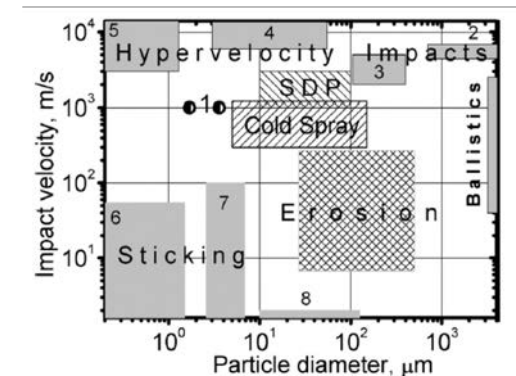
Influence of impact velocity and particle size on features of the interaction [Klinko *et al.*, 2005].

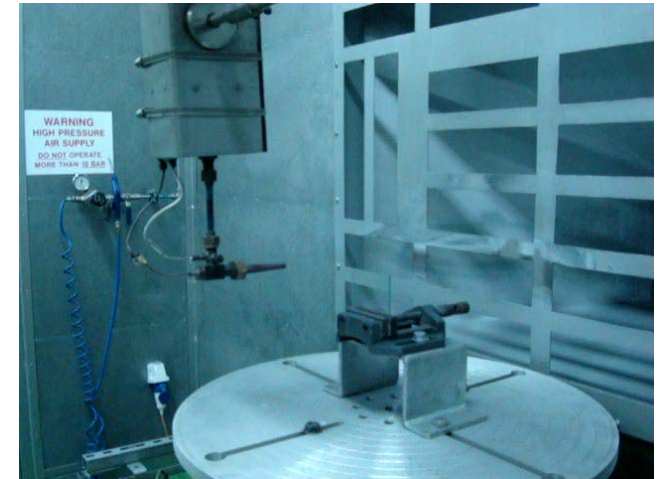
Cold spraying of Al powder on glass substrate at
NTU-ST Kinetics Cold Spray Research Centre

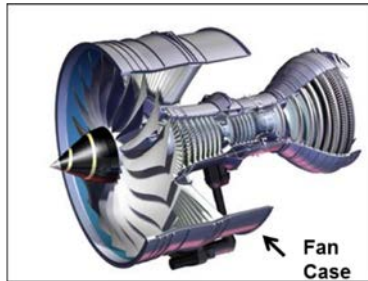
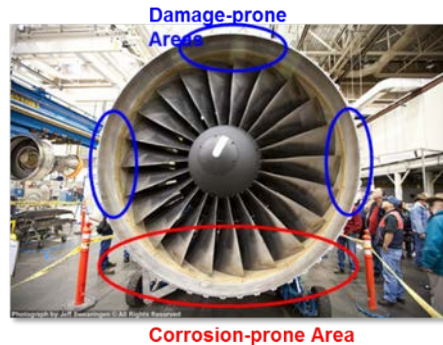
Repair of Corroded Aluminium Gas Turbine Engine Fan Case

Microindentation Hardness (Vickers, 100gf/15 sec)		
Point	Test Coupon	Base Material
1	109.7	105.6
2	97.9	105.6
3	109.2	101.9
4	97.9	104.8
5	108.9	100.9
Average	104.7	103.8

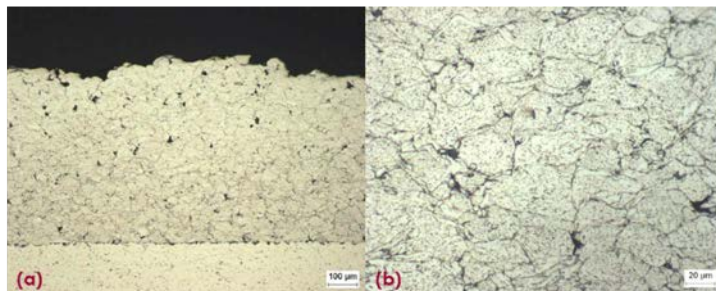
SEM micrographs of a cross-section of the Al6061 coating at (a) 100x magnification and (b) 500x magnification.

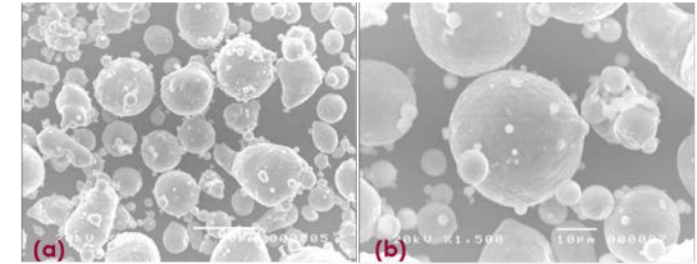
SEM images of the Al-6061 feedstock powder at (a) 500X and (b) 1500X

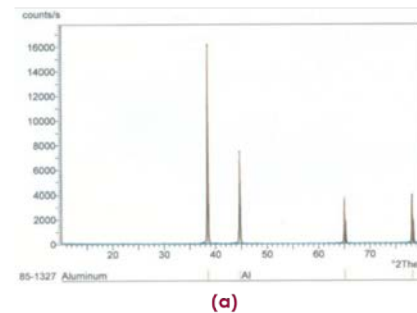
XRD diffraction patterns for (a) Al-6061 powder and (b) coatings produced using Helium gas as carrier gases.

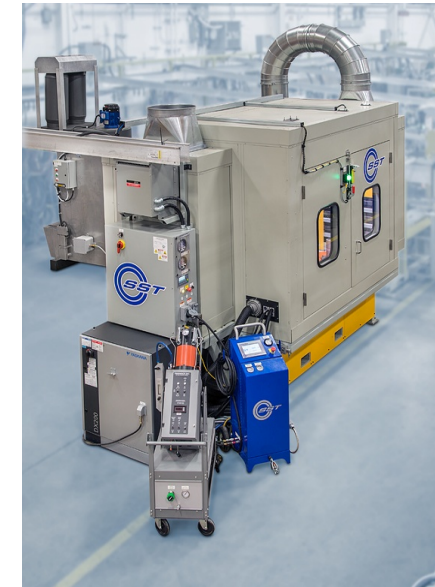
Honeywell

- ✓ Auxiliary Power Units (APU)
- ✓ Propulsion components
- ✓ Fuel/Oil pumps
- ✓ Air cycle machines
- ✓ Gear box housings

- Downstream Injection for Non-structural repair applications
- Repair of casting defects which are picked up after rough machining
- Cold spray has proven to be a viable repair as compared to welding

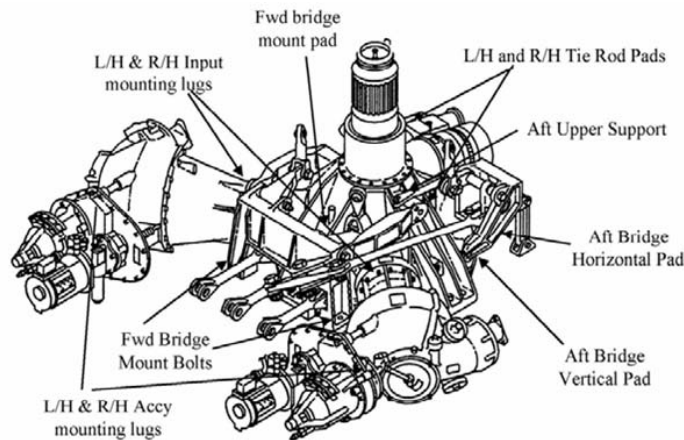
Areas that are most susceptible to corrosion in UH-60 Main Transmission Housing.

- Magnesium alloys commonly used due to excellent stiffness and damping capacity, low density, thermal conductivity, good machinability and wide availability.
- susceptible to galvanic corrosion (one of the most electrochemically active metals)
- anode reaction with other metallic materials common, especially when operating in salt water environment.

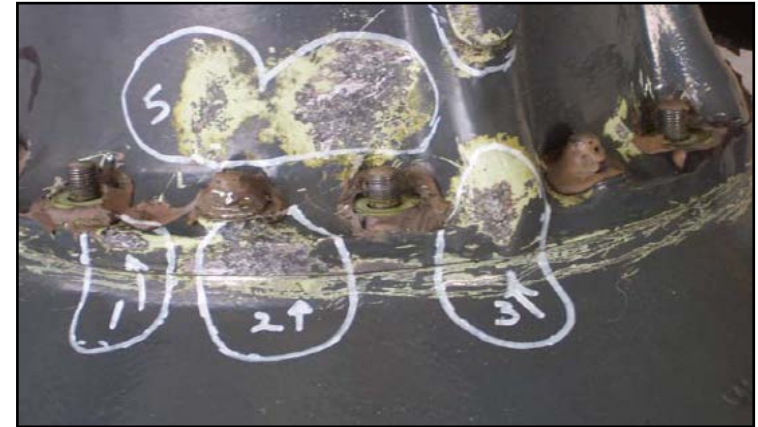
Corrosion locations on a H-53 Tail Gearbox Housing

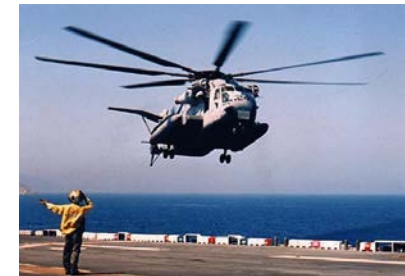
Corrosion on rotorcraft transmission gearbox

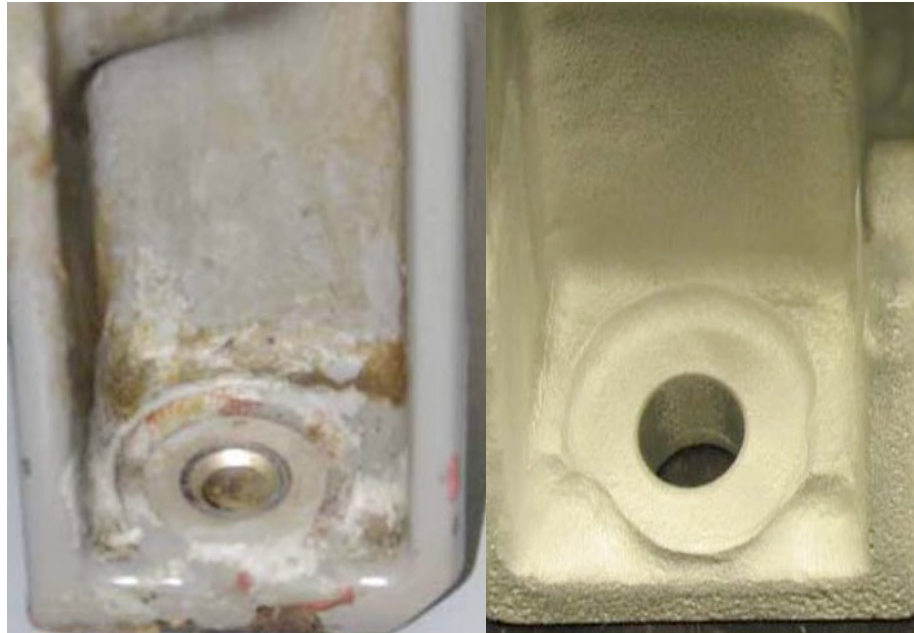
Before and after photos of cold sprayed restored UH-60 Black Hawk main rotor transmission housing.

- Surface preparation (cleaning, oxide removal by scotch brite)
- Masking
- Cold spray
- Final machining
- Dimensional measurements
- Visual inspection
- Final acceptance test (NDT etc)

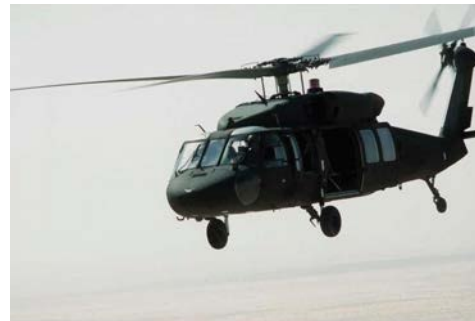
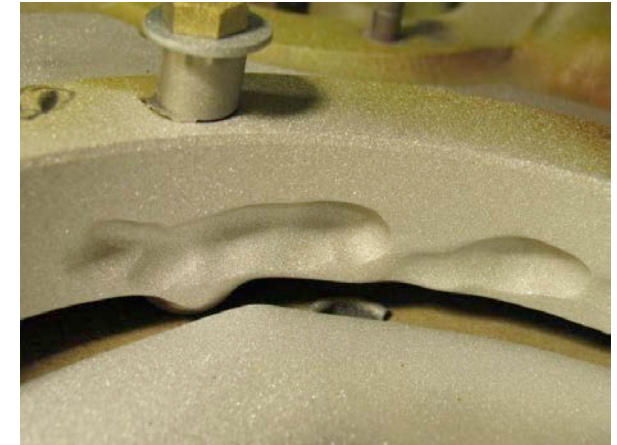
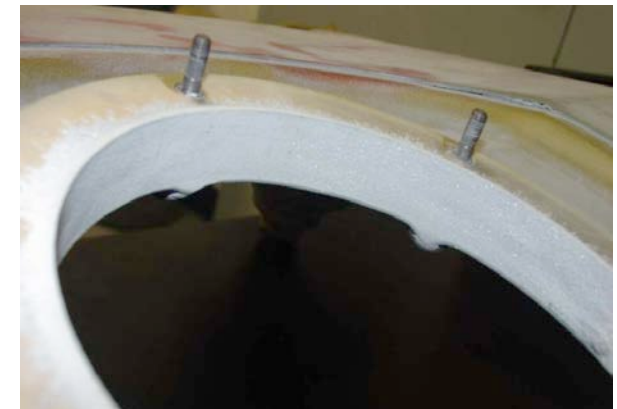
Magnesium helicopter gearbox restored with CP aluminium and 6061 aluminium alloy cold spray coatings

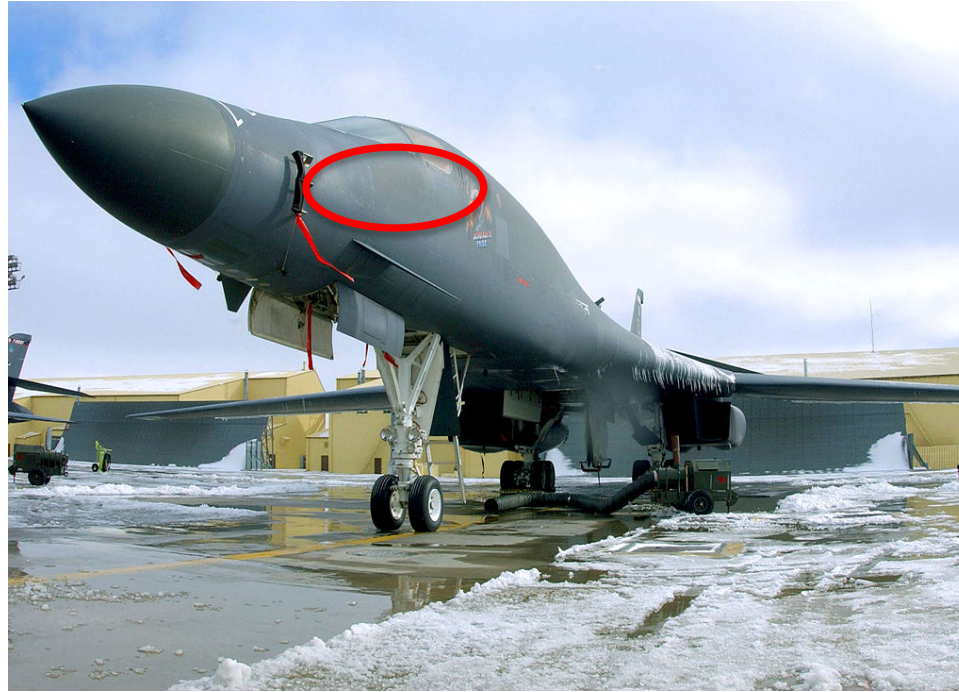
B1 Bomber

- 8 equipment bay panels, 4 on each side.
- Forward equipment bay panel is secured to the airframe with 100° tapered flat head TRIDAIR fasteners.
- Fasteners are designed to be installed flushed with the panel for laminar airflow over skin surface.
- Fasteners are made of steel while panels are made from 2024-T6 aluminum.

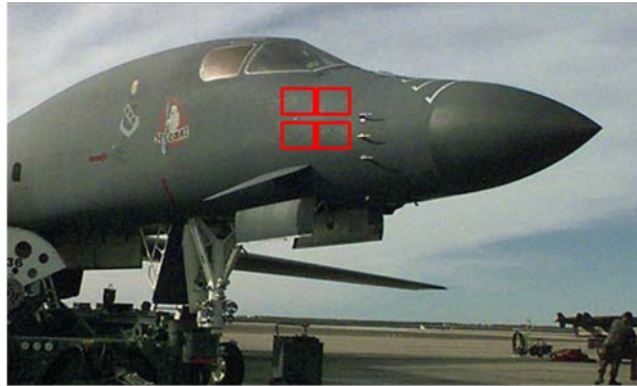
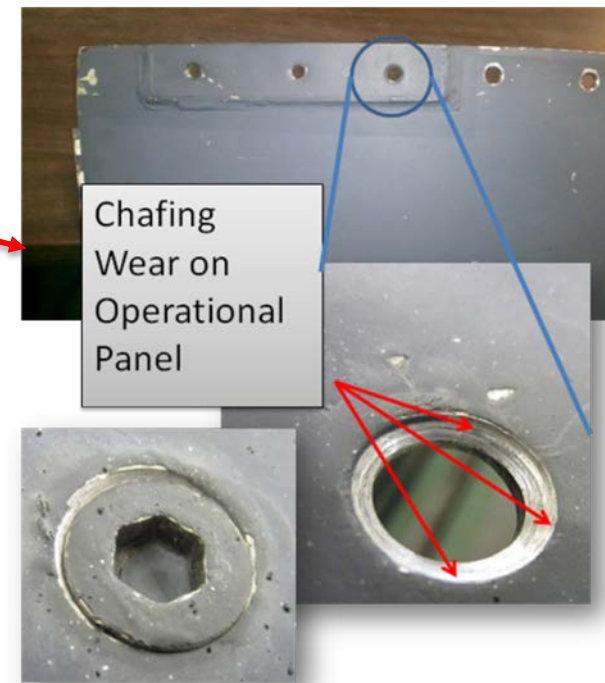
- Repeated opening and closing of the forward equipment bay panels results in chafing wear of fastener holes.
- Fastener holes become elongated and exceed fit tolerance, rendering the panels unserviceable.

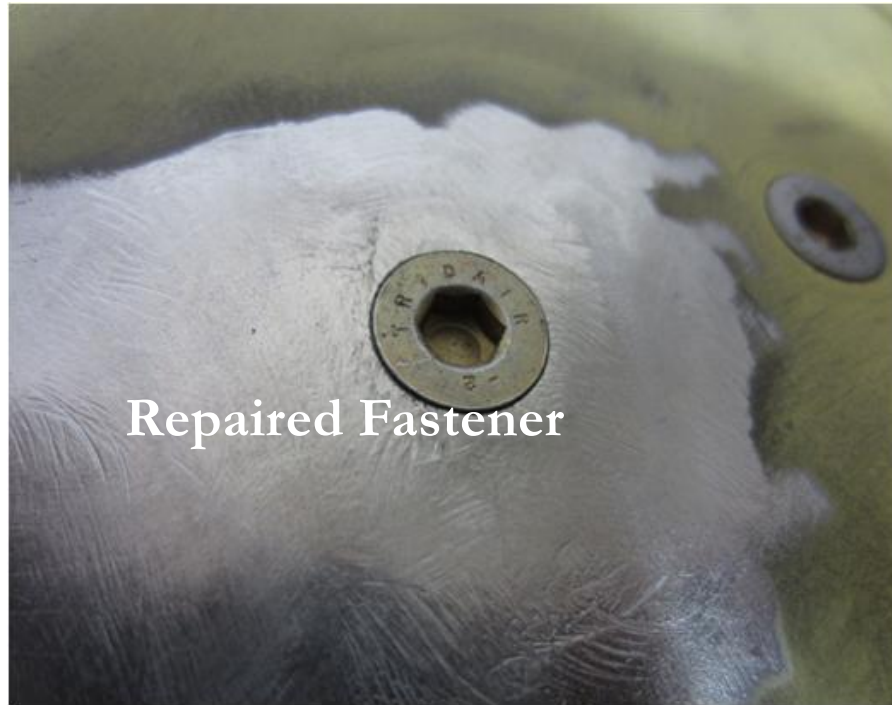
Repaired Fastener

- Al6061 powder cold sprayed on chamfered surface of panel and blended.
- Panel was put through load transfer, fatigue, tensile tests, 3-lug shear test and metallography characterisation.
- Cold spray material did not separate from panel when tested to failure (1.5x bearing yield)
- Fatigue test at 15 ksi tensile stress (typical upper end for aircraft skin load), coupon lasted approx. 500,000 cycles.

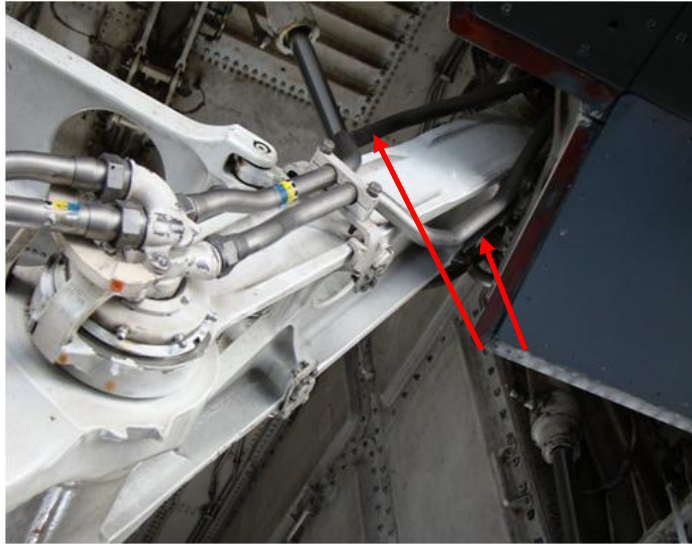
Wheel well titanium hydraulic lines that chafe during flight.

- Vibration and abrasive action result in chafing of titanium ($\text{Ti}_3\text{Al}_{2.5}\text{V}$) hydraulic tubing in the B-1B aircraft.
- 2 areas in which there is high incidence of chafing of hydraulic lines: main landing gear wheel well and wing spoiler actuator.

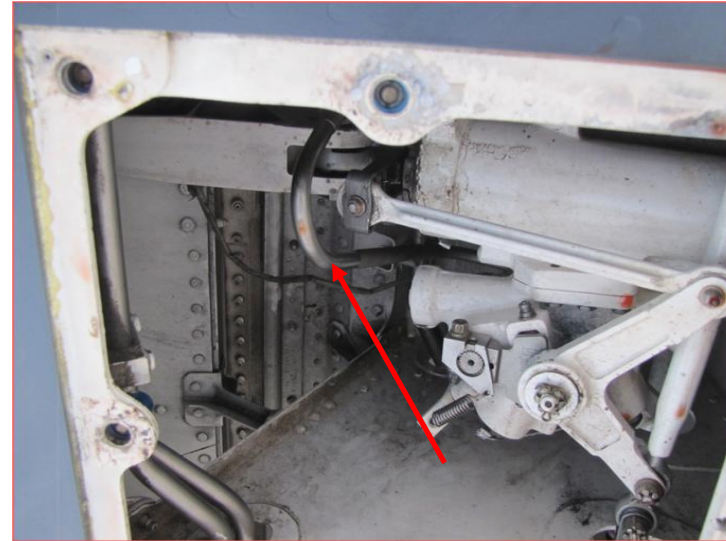
B-1 spoiler actuator lines that chafe during flight operations.

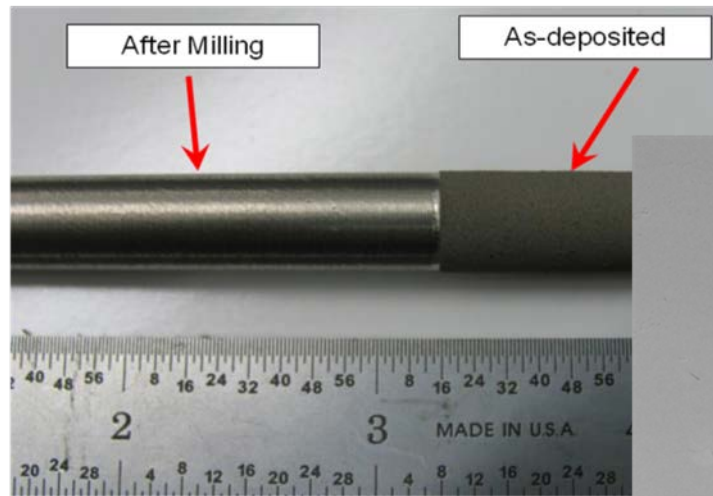
As-sprayed CP-Ti on right and machined on the left.

- Titanium coating was cold sprayed on the titanium tubing as a sacrificial wear surface.
- Effectiveness was validated by bond strength (> 12 ksi), density (99%), hardness (93 HRB), deposition efficiency (70%), microscopic evaluation of microstructure, bond line integrity and porosity ($< 1\%$).
- Operational wear test was subsequently performed on a B-1 nose landing gear accumulator hydraulic line which was cold sprayed coated. The aircraft flew for 4 years with no adverse effects and no observed chafing beyond limits.

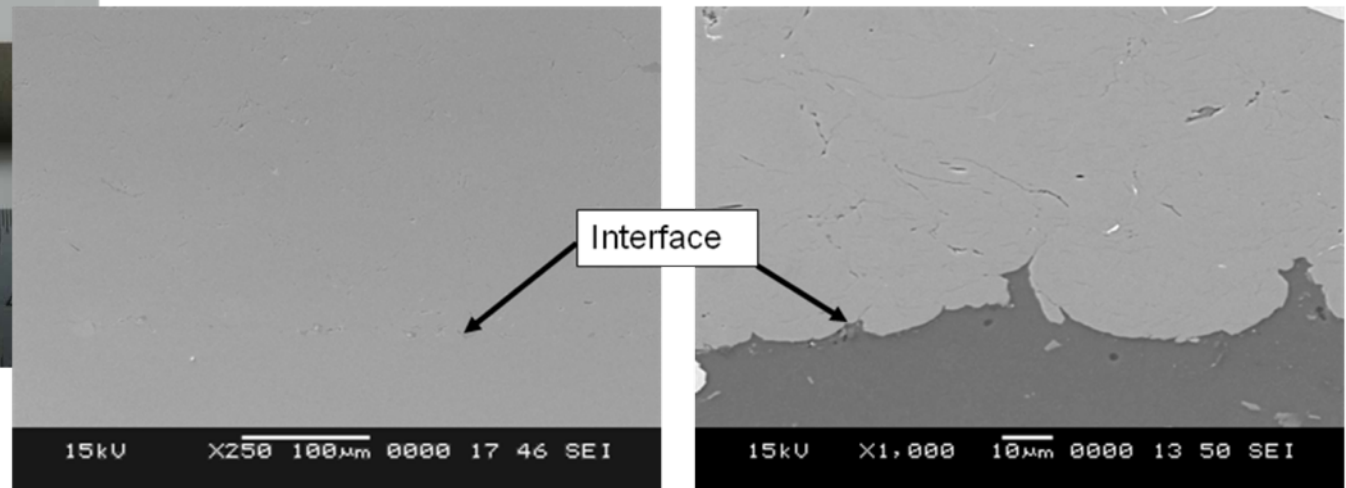
Scanning electron microscopy of the interface between the cold spray CP-Ti coating and the Ti3Al2.5V hydraulic line showing high density and bond line integrity.

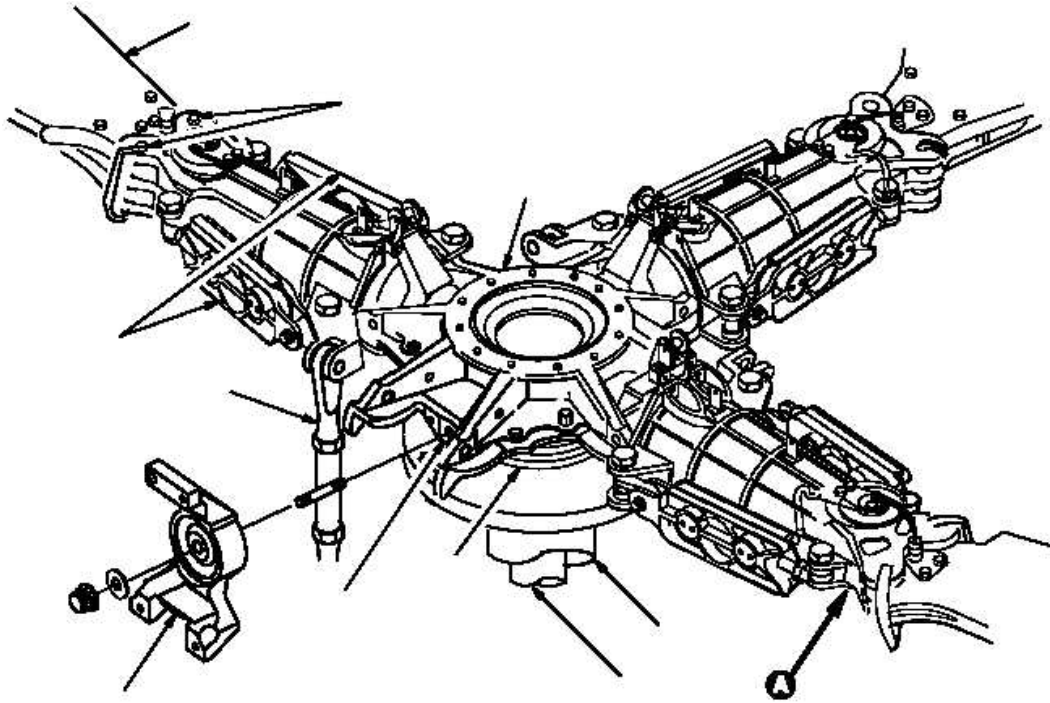
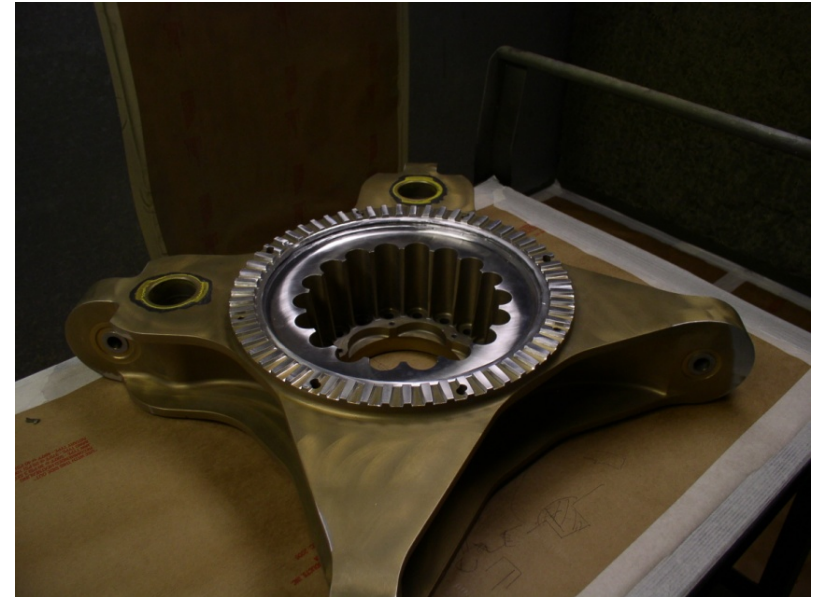
AH-64 Apache Helicopter Mast Support.

- Corrosion and mechanical damaged common on AH-64 mast support, rendering the helicopter non-serviceable.
- Main support fabricated from Aluminum Alloy 7149.
- Remediation without re-building lost material possible but could only be performed for a limited number of times.

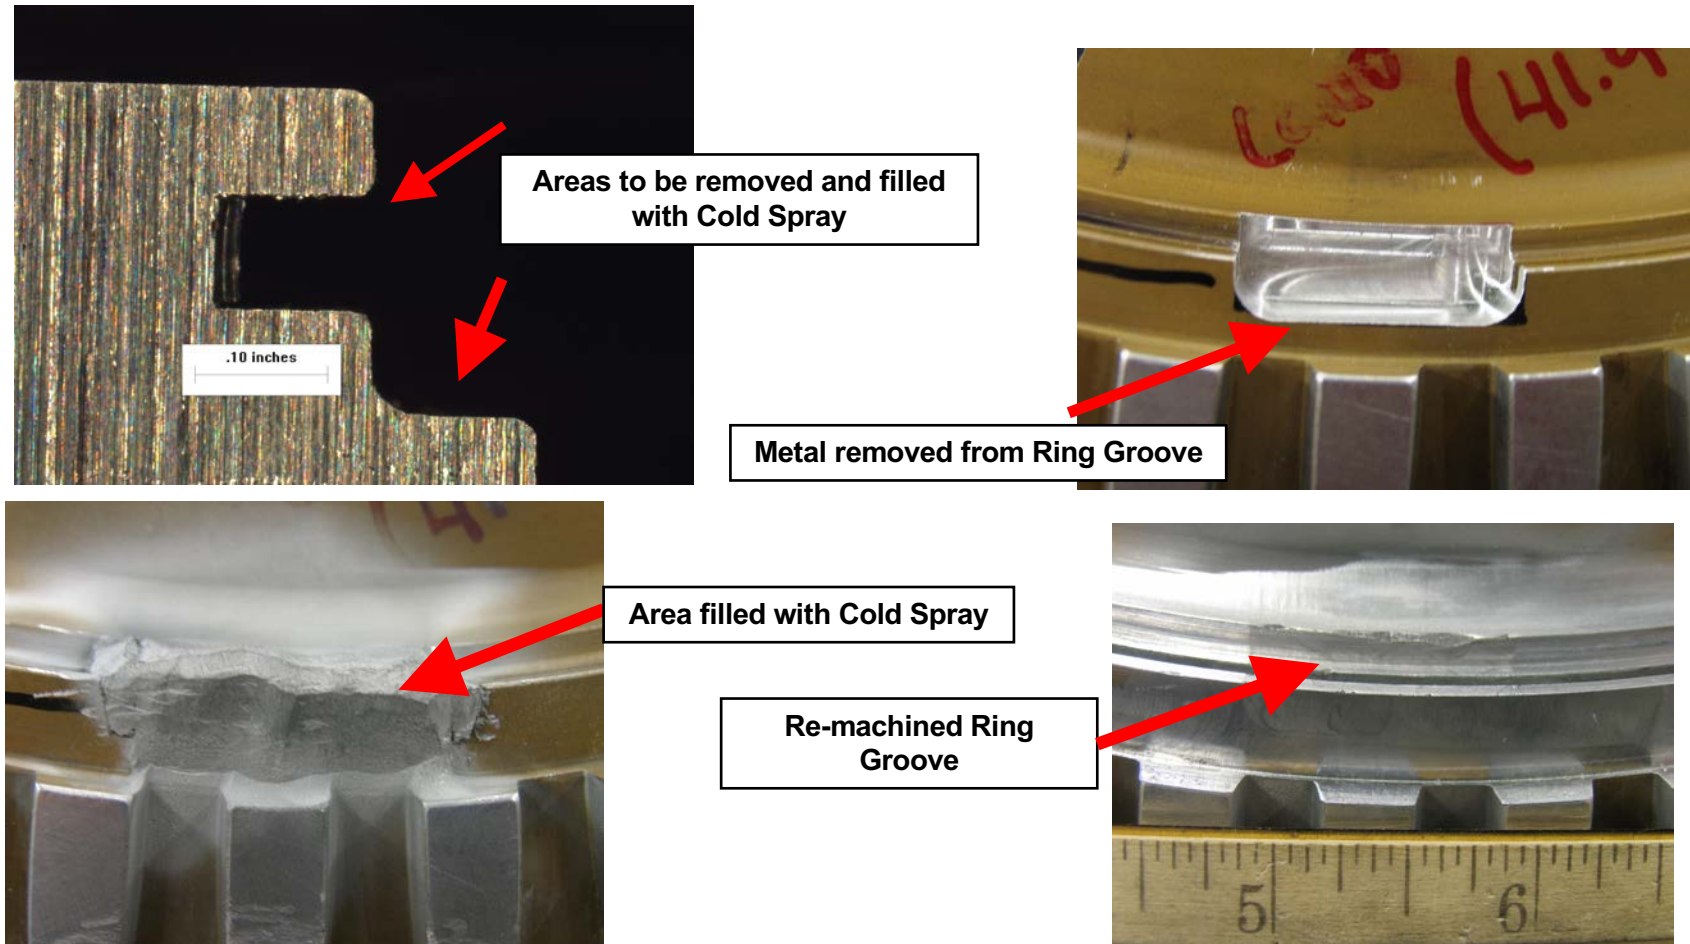
- Corroded or mechanically damaged areas are first blended and machined off.
- Aluminum powder is cold sprayed on the affected area.
- The part is finish blended and machined to original dimensions.

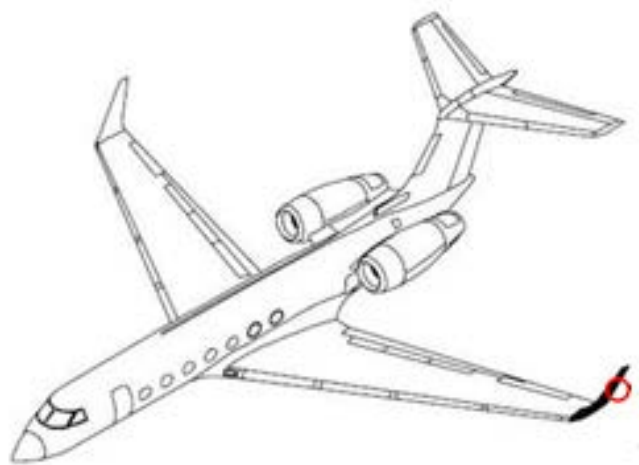
- G550 aircraft (A/C 010) experienced a lightning strike in flight.
- The entry and exit points of the lightning were determined post-flight at the LH winglet, based on the burnt mark.
- The burnt mark on the winglet is approximately 1" length by 1/4" depth.

G550 Winglet damaged by lightning.
