The Gulfstream IV operator had all the appearance of a good operation but the flightcrew lacked cockpit discipline

NTSB finds widespread non-compliance with checklist use and control checks, leading to this tragic BED runway overrun crash.

By Robert Sumwalt
NTSB Board Member
ATP/CFII/FE. Airbus A320, King Air 350, Boeing 737, Fokker F28, Fokker 100

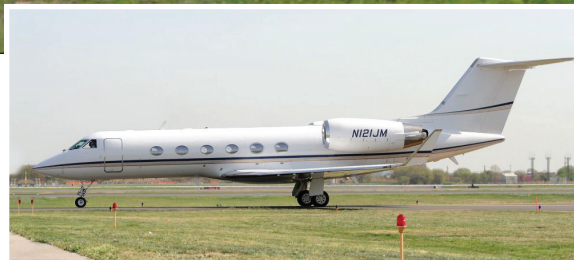
Flightcrew failure to review the checklist and release the gust lock prior to the takeoff run of Gulfstream IV N121JM on BED's 7000-ft Rwy 11 as well as failure to be time-sensitive and abort the takeoff before running out of runway length led to destruction of the aircraft and the deaths of all occupants aboard.

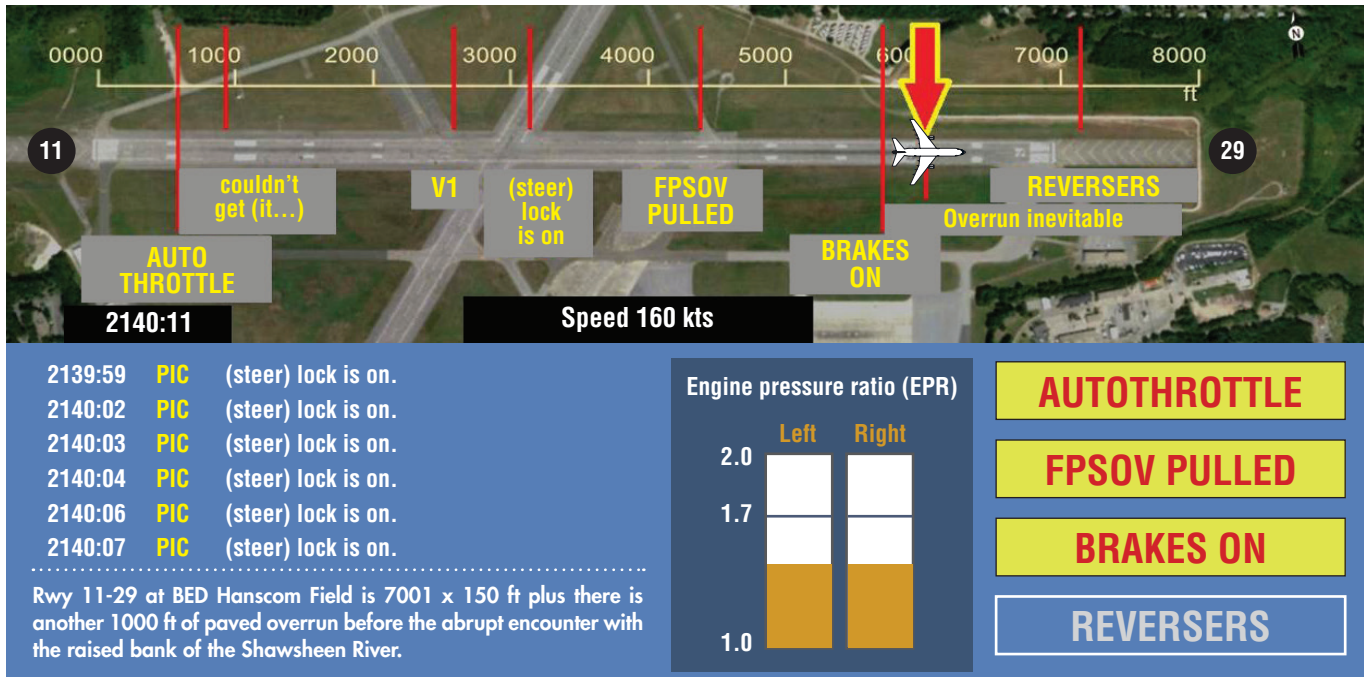
Releasing the gust lock is the 4th item on the GIV Starting Engines checklist contained in the airplane flight manual (AFM), as well as the FlightSafety checklist used by the pilots in training. Not only did the CVR reveal this checklist was not verbalized, but neither of the 4 remaining check-

lists were verbalized either. Although it's possible that the checklists could have been accomplished silently, which would have been contrary to their training which called for "challenge-response" checklist execution, the NTSB noted there was no discussion of checklists before, during, or after engine start or throughout taxi, and there were no cockpit statements recorded to denote the checklists were completed. Furthermore, a contract pilot who had flown with one of the pilots a few years before the crash told investigators that the pilot did not use checklists, but rather, had memorized a way of doing things. The NTSB concluded "the crewmembers' lack of adherence to industry best practices involving the execution of normal checklists eliminated the opportunity for them to recognize that the gust lock handle was in the ON position and delayed their detection of this error." Obviously, there was a big hole in the checklist layer of defense.
