Aircraft Rescue and Fire Fighting Capabilities: Are Today's Standards Protecting Passenger's Futures?

Aircraft Rescue and Fire Fighting Capabilities:
Are Today's Standards Protecting Passenger's Futures?

Graduate Capstone Project

For the Degree of
Master of Science in Safety Science

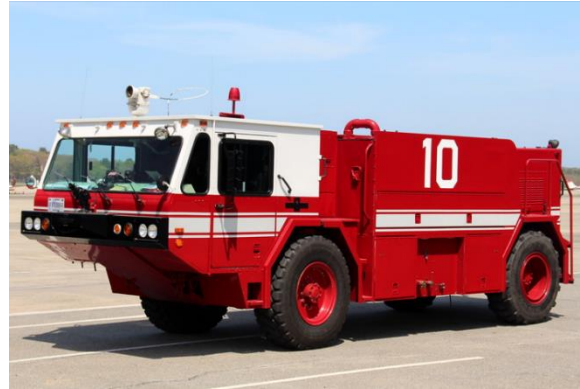
Figure 8. (Right) Variations of Crash 10

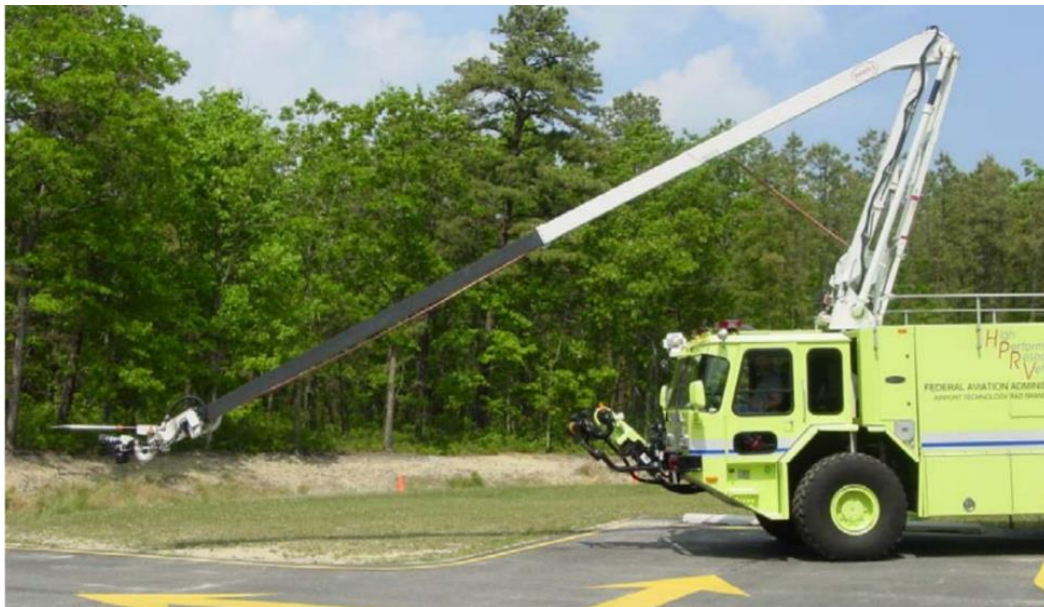
Figure 22.

Exhibit T- High Reach Extendable Turret with Skin-Penetrating Nozzle. The HPRV with HRET in a Down-in-front attack mode. Source, Department of Transportation, Federal Aviation Administration, Office of Aviation Research and Development.

Another significant issue recognized in hindsight to Asiana Flight 214 was the problems involving the use of the high-reach extendable turret’s (HRET), which were equipped on the two most sophisticated ARFF vehicles, Crash 9 and Crash 10. The National Transportation Safety Board determined that, while the vast majority of firefighting operations were successful and greatly improved passenger survivability, ARFF operations could have been improved in that the HRET-equipped vehicles were not effectively used in the initial response. This is reflected in the timeline (Figure 22), which displays numerous situations where ARFF vehicles repositioned. The accident report explained that in several situations, the repositioning of the ARFF vehicles was neither effective nor safe. Crash 9 specifically was maneuvered into an area where there were still passengers evacuating, increasing the risk of a strike or rollover occurrence. Both vehicles were at one point positioned in locations that could not effectively fight the growing fire to protect evacuation routes. Additionally, it was whole 20 minutes after each vehicle arrived on the scene before either used the HRET to penetrate the fuselage and dispense agent inside.
