Low-velocity Impact Analysis of Composite Repair Patches of Different Shapes

A Thesis

Master of Science in Aerospace Engineering

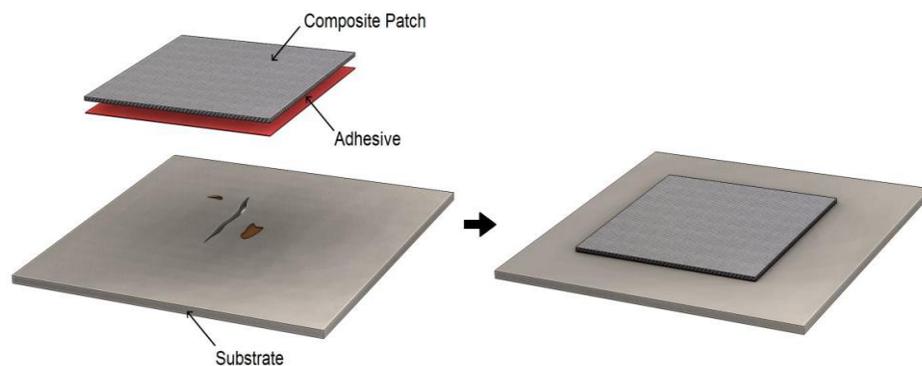
Figure 2. 1 Composite patch repair of a damaged area

Composite repair solution is an alternative to conventional methods. Composite patch repair is a recent approach to repairing damage plates or any material structures. A composite laminate acts as a patch which is used to bond adhesively over a defected area in order to restore the load carrying capacity of the structure. The way it works is like a patch transfers loads around the defect and stops the defect from growing. The best part of it is that the composite patch can be applied directly on the cracked material without the use of hot work. This largely eliminates the fear of explosion hazard. In oil and gas industry this method is very much favorable. Here cold joining processes minimizes the impact of maintenance work or modifications due to the reduced danger of explosions. Some of the repairs may be used as a temporary solution until scheduled maintenance may be performed.

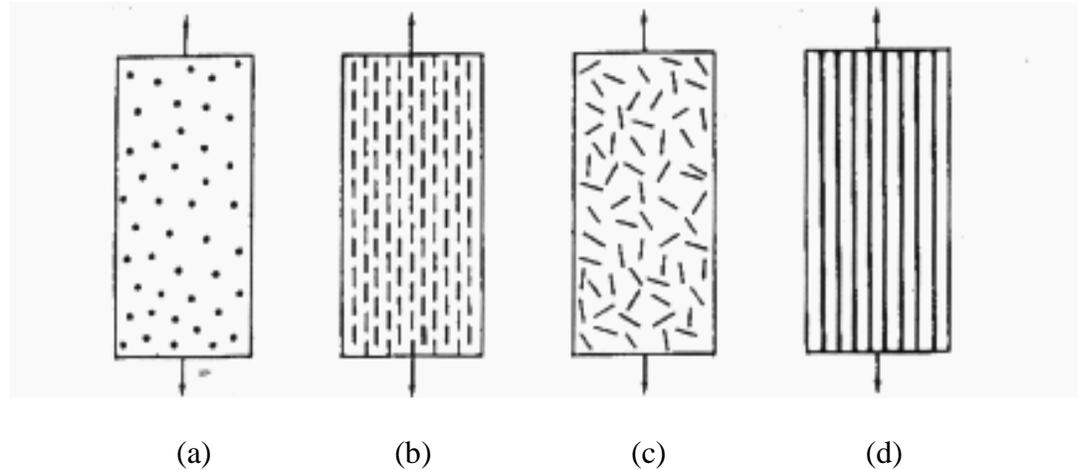
Another method of classifying composites is based upon the type of reinforcement pattern. They are; (a) Particulate random, (b) Discontinuous aligned, (c) Discontinuous random, and (d) Continuous aligned

Figure 2. 2 Arrangement and types of reinforcements

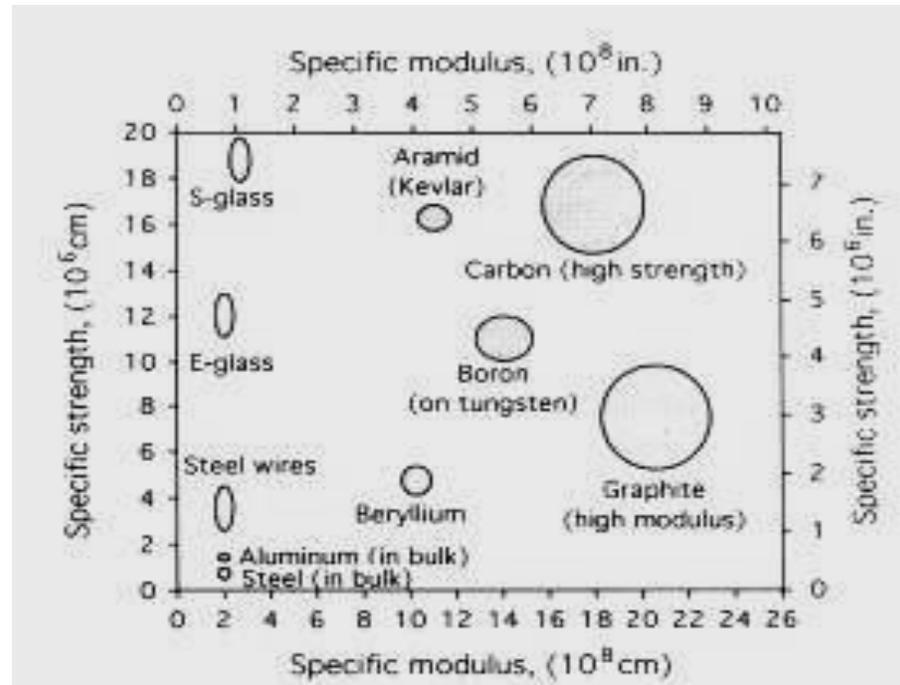
The most common form of reinforcement used is fiber. Generally most of the materials are stronger and stiffer in fibrous form as compared to any other form. Fibers have high stiffness and low density. Glass fiber, carbon fiber and boron fiber are the most common types of fiber materials used in composites. Comparison of various fibers is shown in figure 2.2.

Figure 2. 3 Mechanical properties of different fiber

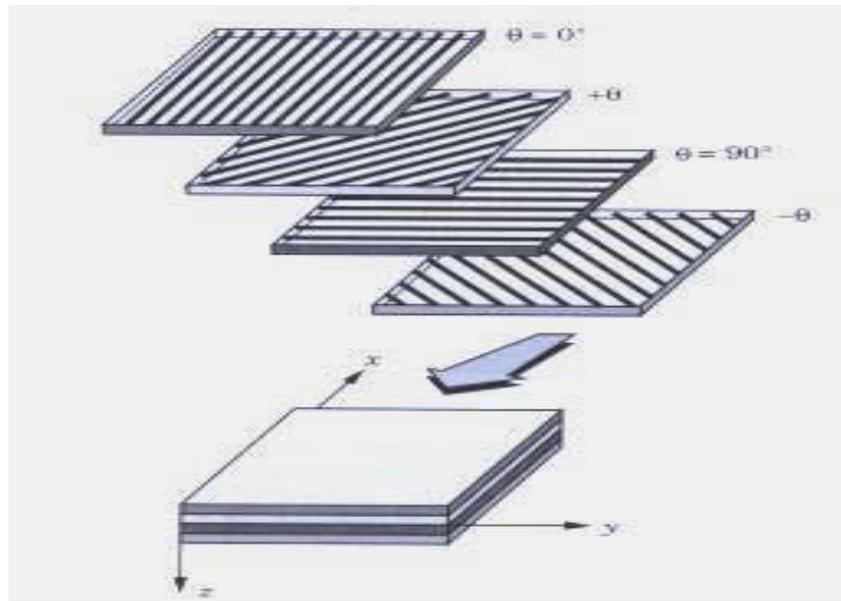
Since there is no contribution of fibers towards the strength in transverse direction, also considering that the strength of the matrix is low, it becomes essential to place the fibers in different directions in order to undergo the loads of any amount. The preferable angle of orientations of lamina are 0°, 45°, -45°, and 90°. The axial load is carried by the lamina with 0° degree angle, 45° and -45° angled plies carry shear loads and the lamina with 90° carry the load in transverse direction.

Figure 2. 4 Lamination sequence

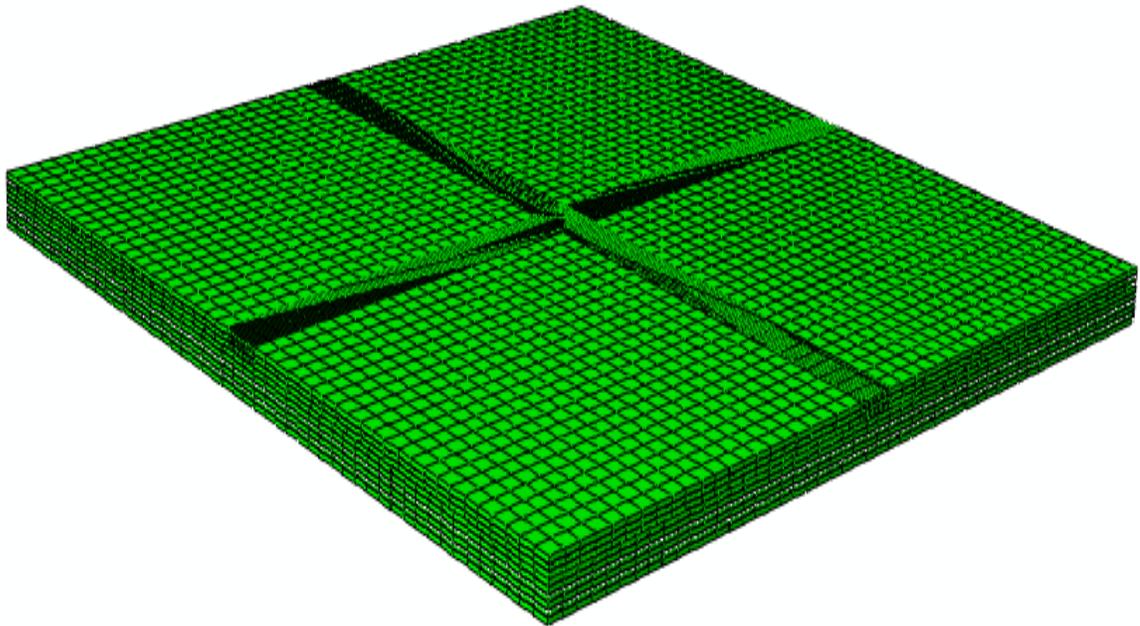
An impactor was modeled, providing impact energy of 20 J and velocity of 4.472 m/s. A friction penalty of 0.5 was provided for the contact between the impactor and the composite layer.

The impact simulation was run in Abaqus/Explicit, with a time span of 0.001 seconds. The linear bulk viscosity parameter was set at the recommended value of 0.06, and the quadratic bulk viscosity parameter was the recommended value of 1.2.

Figure 4. 1 Modeling of the composite laminate

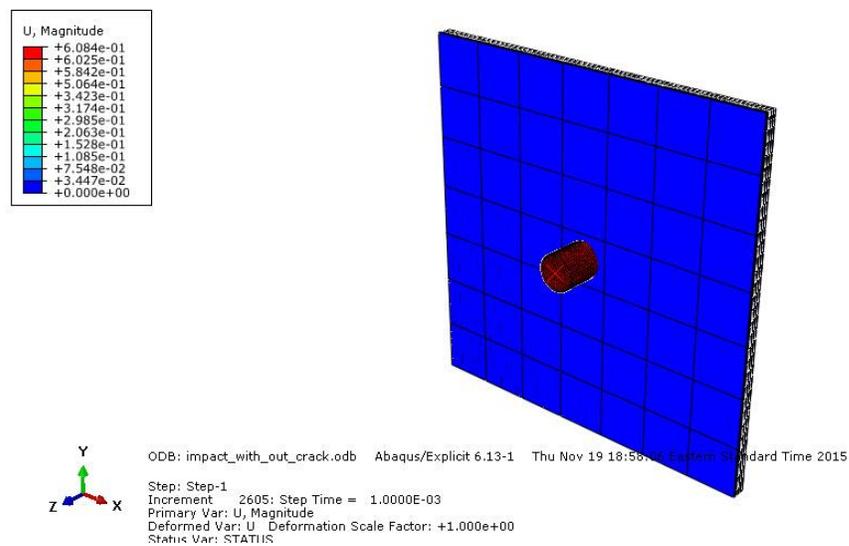
Figure 4. 3 Displacement for 44149-elements model

The above figures show the comparison of displacement based on fine mesh and coarse mesh size.

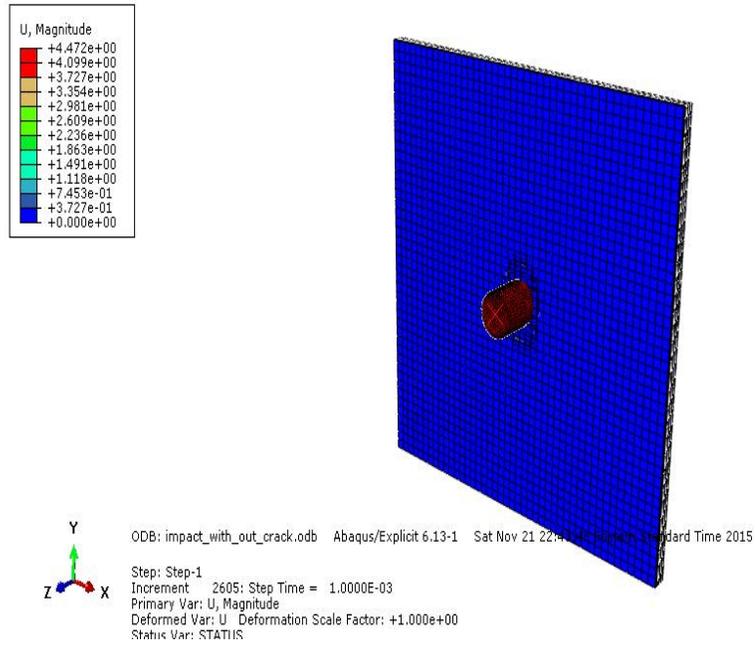
Figure 4. 4 Displacement for 49284-elements model

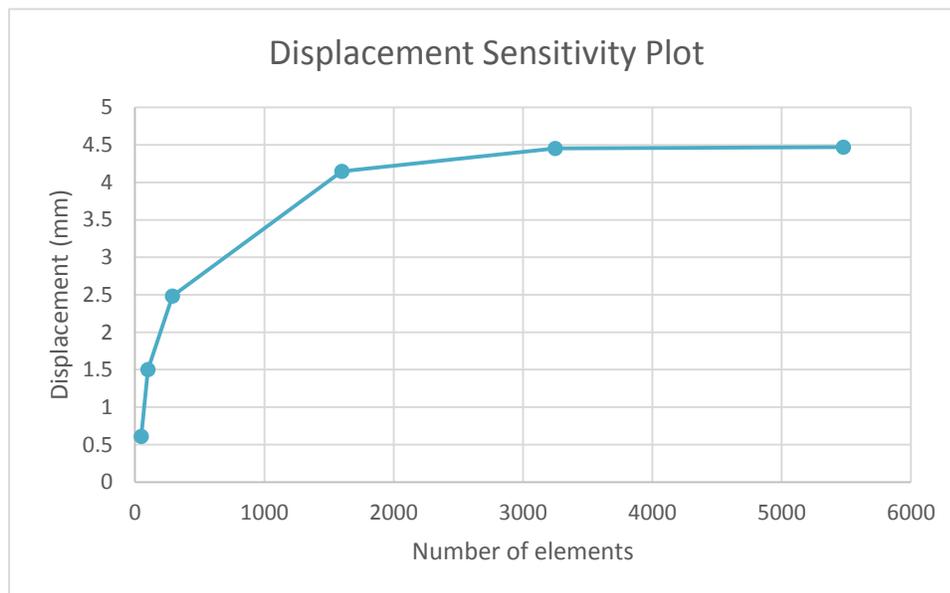
Figure 4. 5 Displacement sensitivity plot

Figure 4.7 is the plot between displacement and number of elements and figure 4.8 is a plot between Von-Mises stress and number of elements. It can be observed from the plots that the graph of displacement and Von-Mises stress converges when the number of elements are 49284.

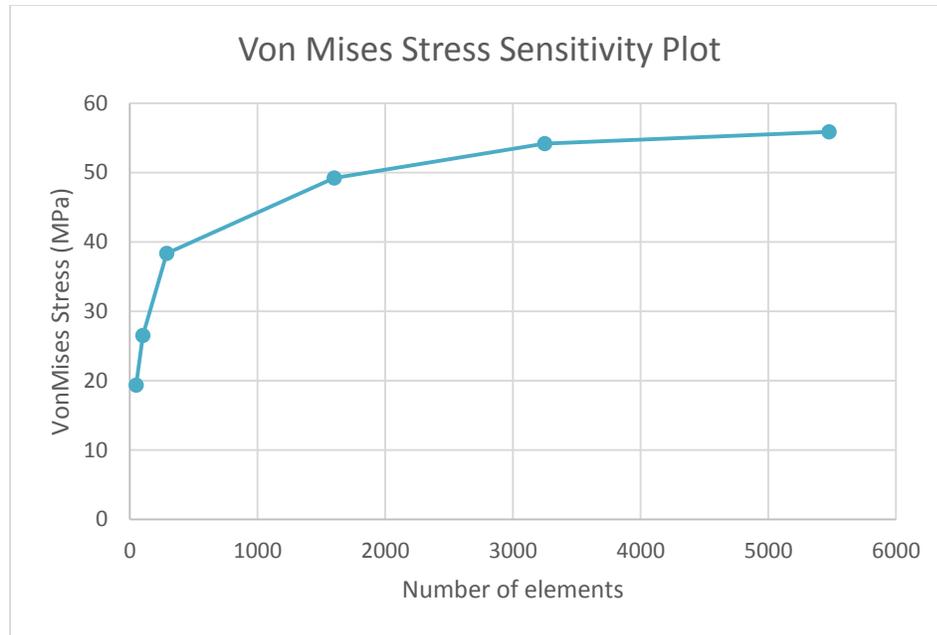
Figure 4. 6 Von-Mises stress sensitivity plot

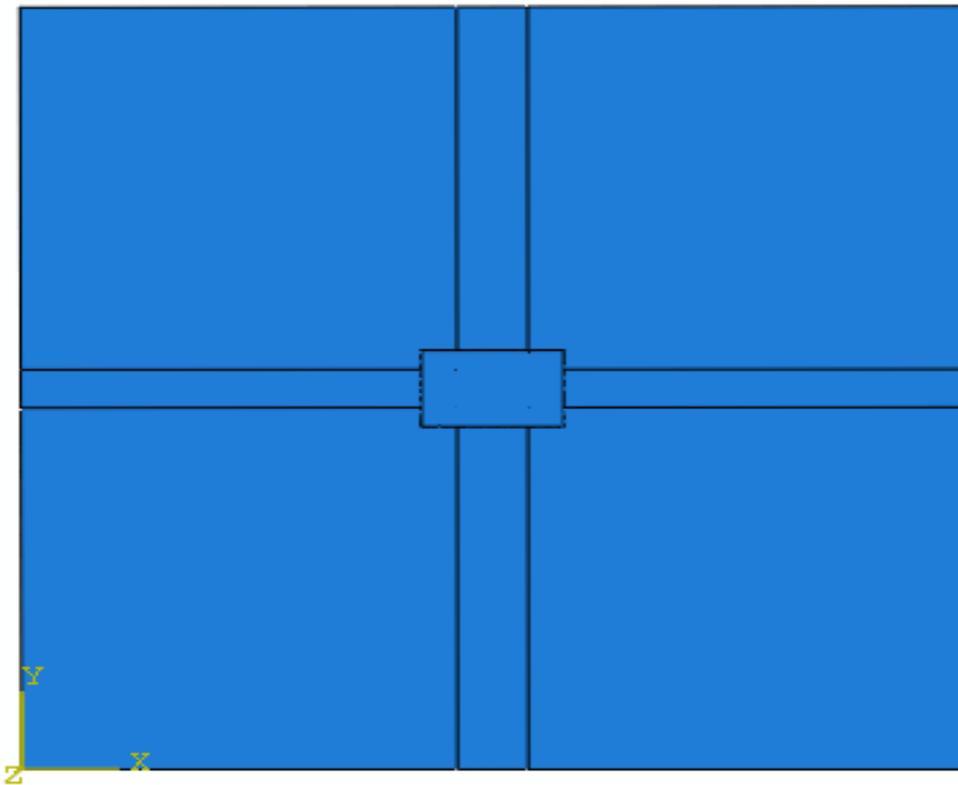
The rectangular patch that was used had dimensions 15 mm x 6.7 mm. The thickness of this patch was kept the same as 1 mm.

Figure 5. 1 Rectangular patch model

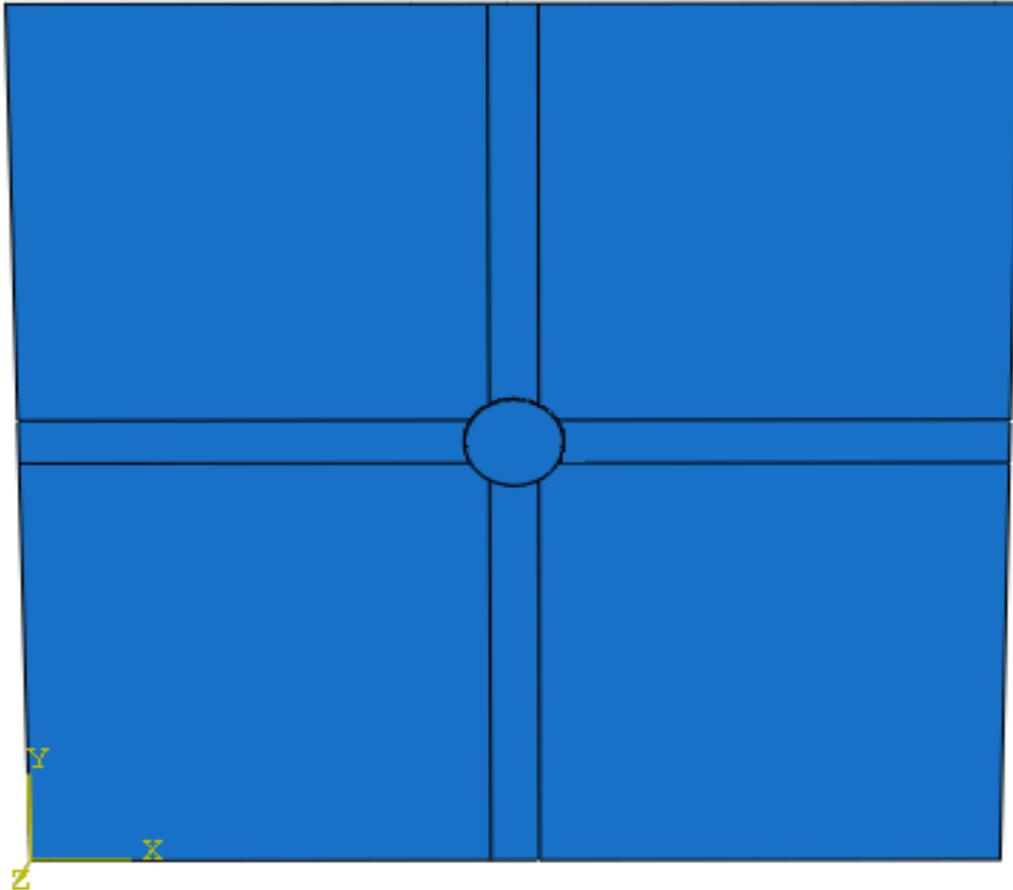
The next repair patch model that was designed was the circular shape. For the circular patch shape the dimension was taken as 5.65 mm radius. This dimension was

taken into consideration, in order to maintain the uniformity in the surface area of the patch. The surface area of the circular patch was approximately 100 sq.mm.

Figure 5. 2 Circular patch model

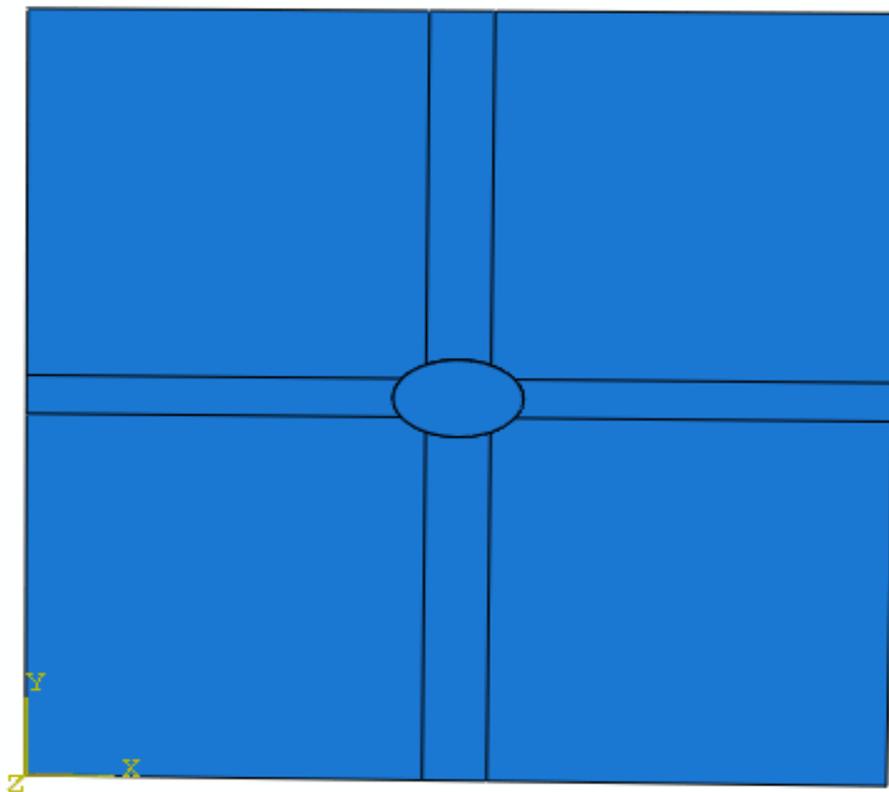
The shape of the next patch that was considered was ellipse. Since, the area of the ellipse should be the same as that of the other composite patches, to define this similarity, the dimension of the ellipse was taken carefully into consideration. The major axis of the ellipse was taken as 15 mm and the minor axis was taken as 8.5 mm. In this manner when it's surface area was calculated it gave the value approximately around 100 sq.mm.

Figure 5. 3 Elliptical patch model

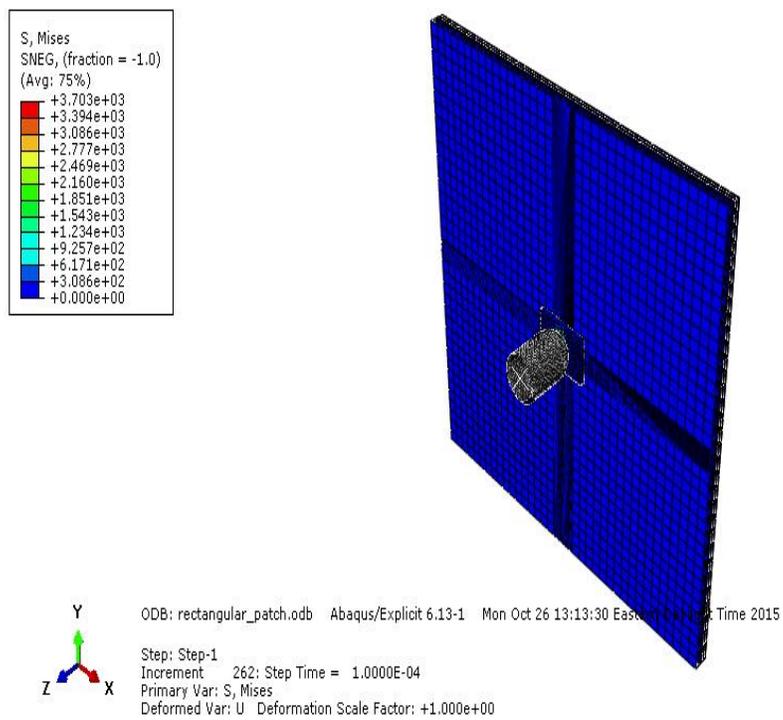
Around the crack tip, a rectangular mesh pattern was created. Around the rectangular pattern another rectangular area was created. The displacement on the rectangular patch shape after analysis was found to be 0.448 mm. Fig 6.1 shows the Von Mises stress from the analysis.

Figure 6. 1 Von Mises stress for rectangular patch

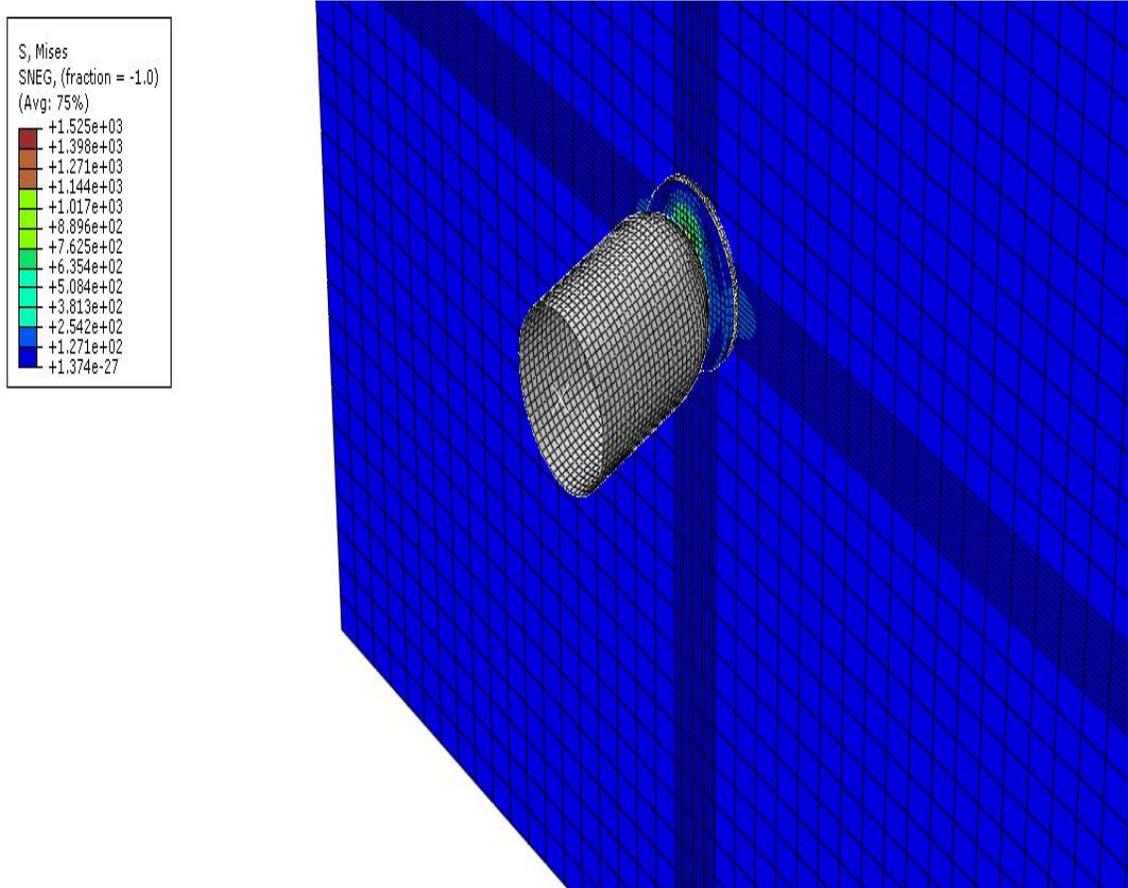
A circular patch was placed on the crack surface. The displacement in the patch was found to be 0.42 mm. The Von Mises stress on the circular patch is as shown in figure 6.2. The displacement in this patch was found to be 0.4472 mm.

Figure 6. 2 Von Mises stress for circular patch

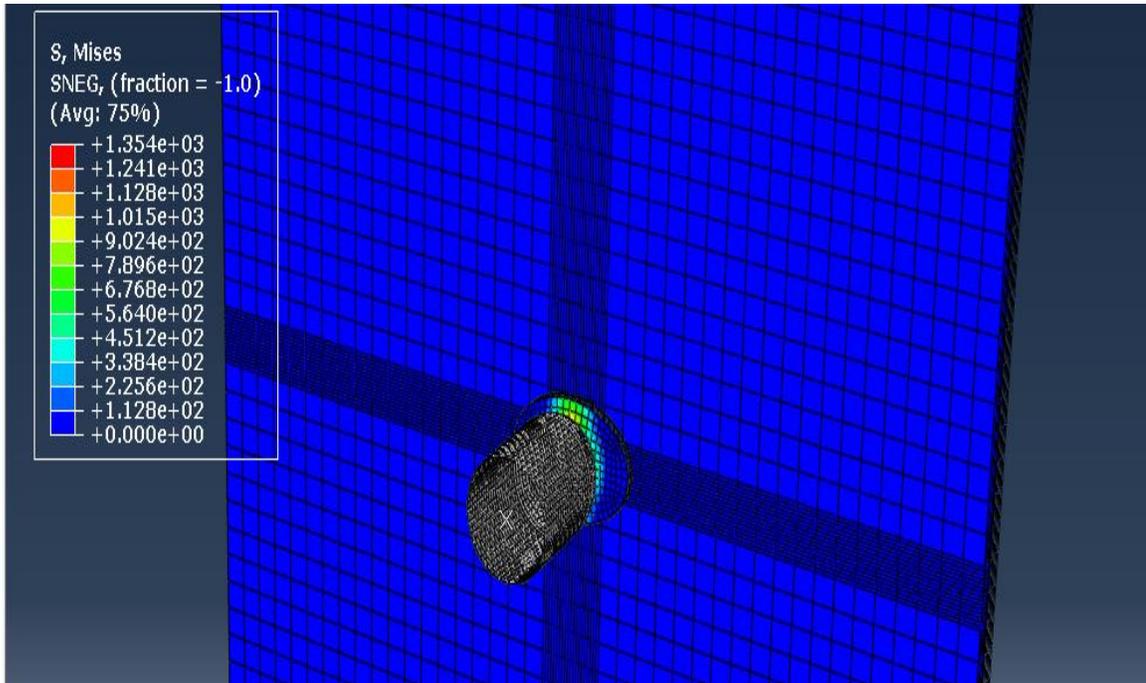
Elliptical patch was the last patch that was modelled in the test.

Figure 6. 3 Von Mises stress for elliptical patch

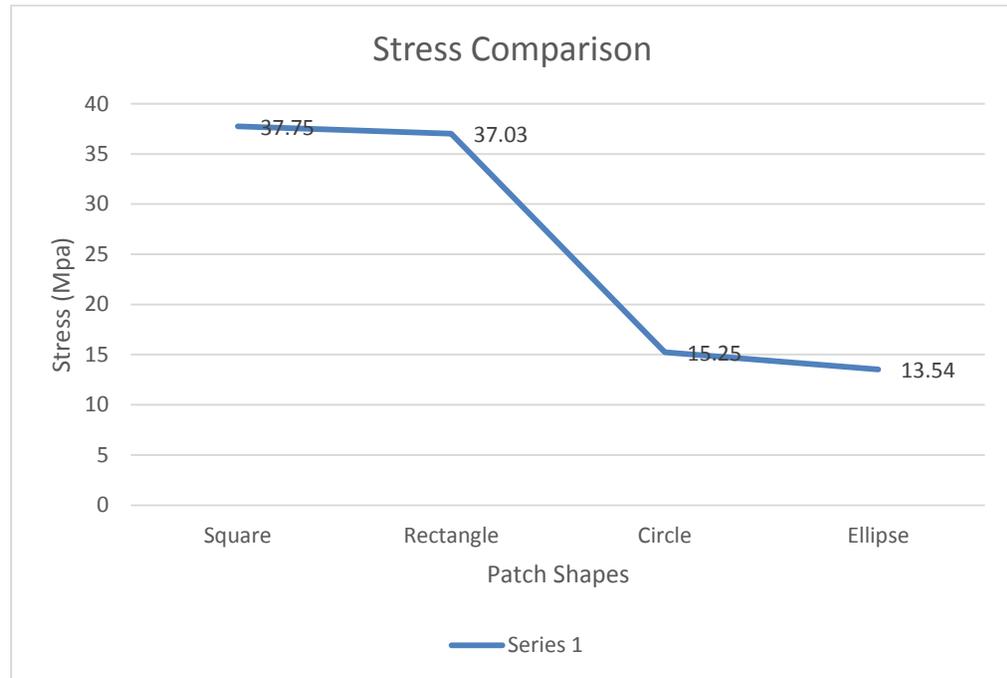
Figure 6. 4 Stress comparison

Figure 6.4 shows the Von Mises stress concentrated on various patch shapes. The Square patch has the highest stress concentrated which comes to 37.75 MPa. The rectangular patch has stress lower than square patch which is 37.03 MPa. The circular and elliptical patch has stress far lower than the quadrilateral. The circular patch has stress concentration of 13.92 MPa. Elliptical patch shape has the lowest stress of all the patch shapes which is 13.54 MPa.

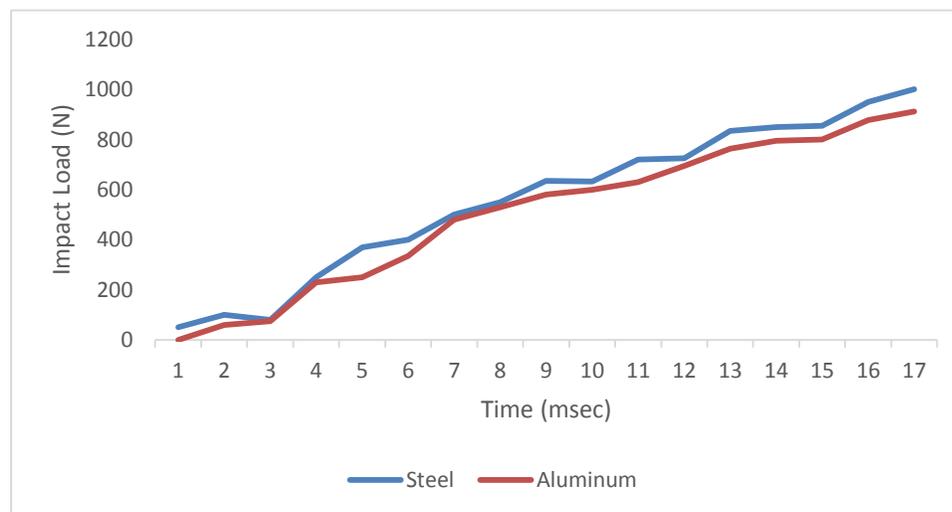
Steel and aluminum projectile were used for parametric study of impactor material. The impactor diameter and velocity were kept the same as that used in the tests. This study was specifically to see the effect of changing material of the impactor on the impact damage. There were differences observed in the impact force with the change in materials. Having the same impact velocity, aluminum and steel had the kinetic energy in a similar ratio. The maximum impact force of steel was found to be 1000.5 N and that of aluminum was 912 N. Figure 7.1 shows a plot of impact force vs time for both aluminum and steel impactor materials.

Figure 7. 1 Steel and aluminum impact comparison

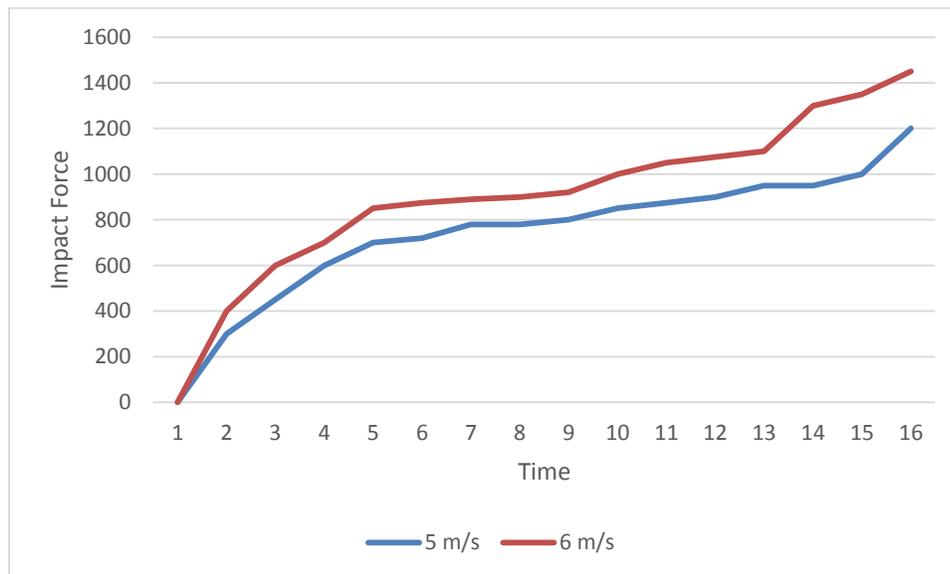
The next parametric study was conducted for the change in velocity of the impactor. The impactor given in the experimental setup is used the way it is. The velocity is given as 5 m/s and 6 m/s. The maximum damage is high as compared to that of the velocity used in the experiment. Since the velocity is more, the impact damage would be greater too. Following is the table comparing the impact force vs time for velocities 5 m/s and 6 m/s.

Figure 7. 2 Comparison of impact force of different velocities
