## The Longest Flight

Brady, T. (1972). The Longest Flight. *TAC Attack*, 12(). Retrieved from <https://commons.erau.edu/publication/463>

# THE LONGEST FLIGHT

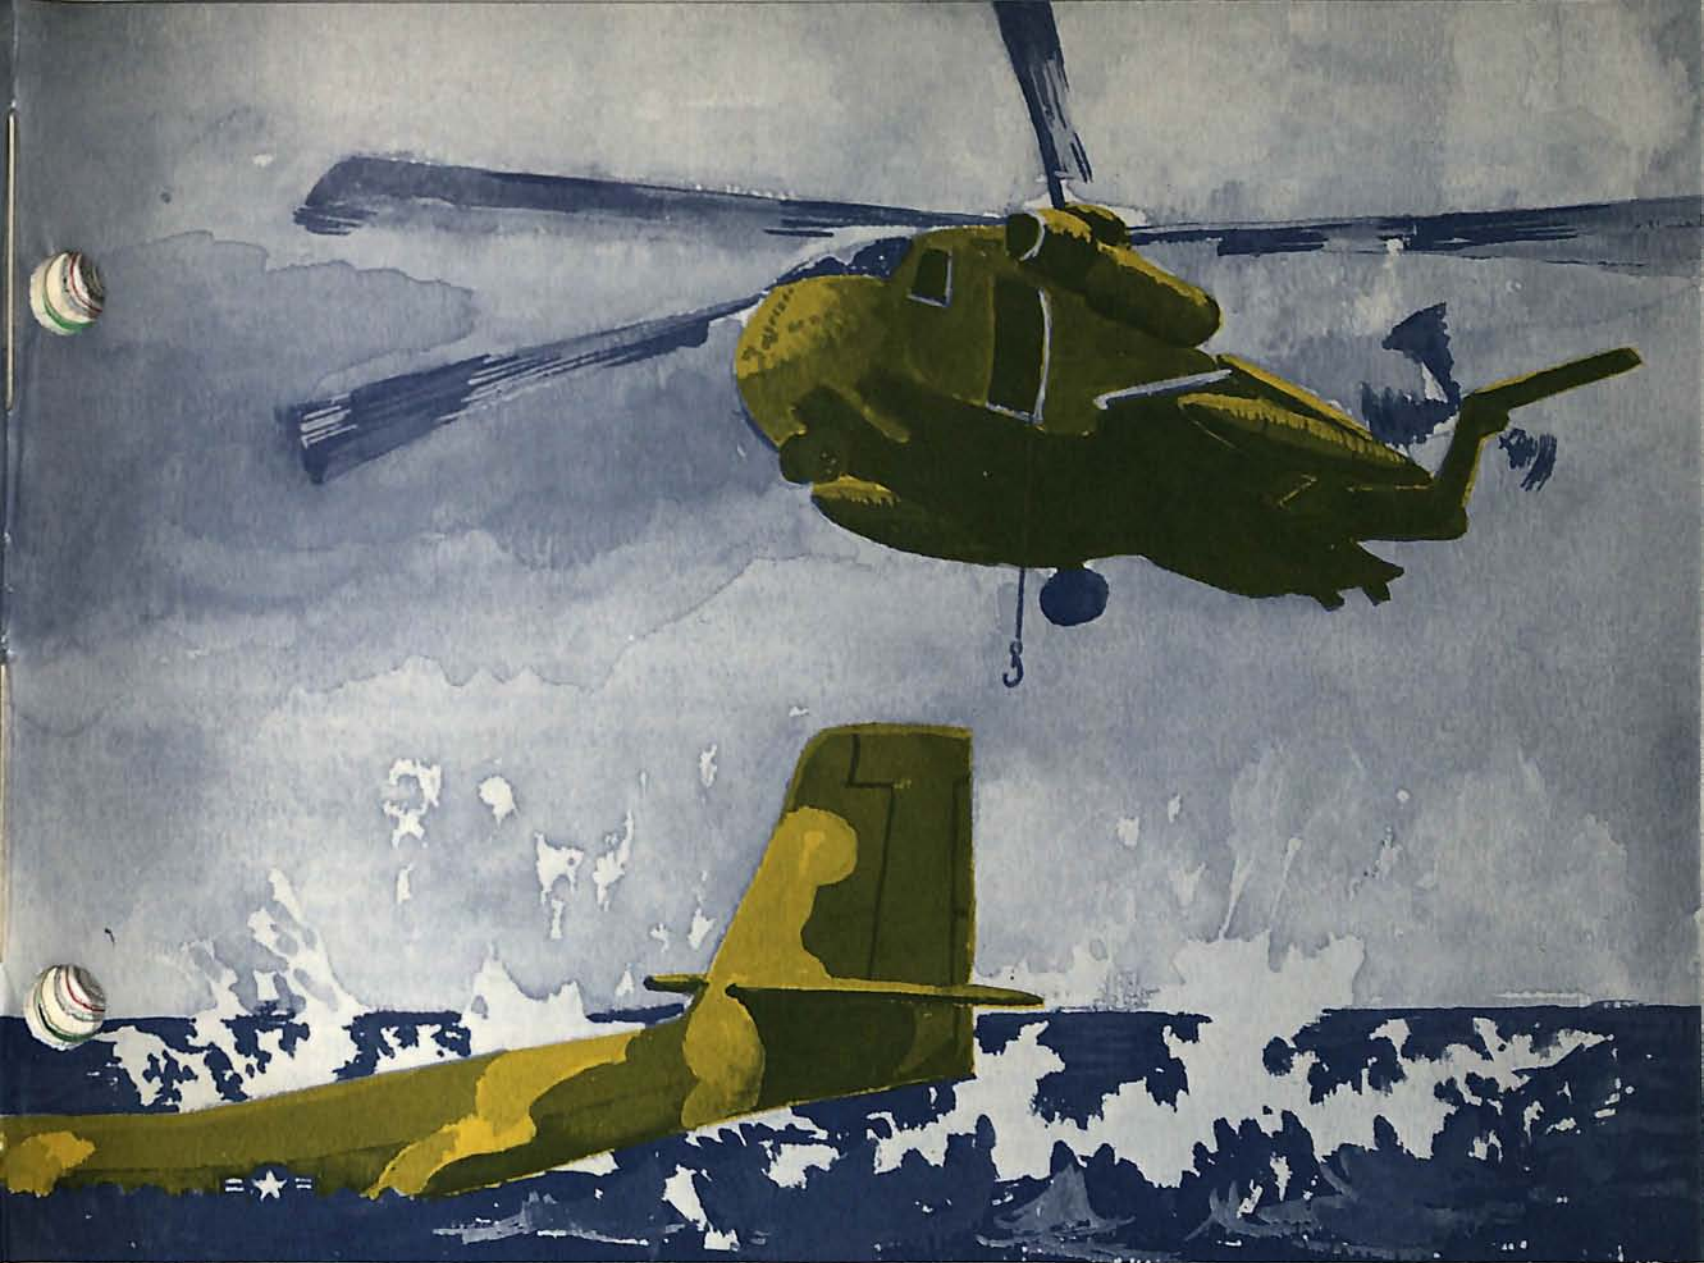
At about ten hours and fifteen minutes into the flight, the low oil quantity light for the left engine illuminated in the number two airplane in the stream. There was nothing alarming or unusual about it; the engine had been steadily using about a gallon of oil per hour on the previous legs. The pilot sent the flight mechanic to the rear of the airplane to reservice the oil quantity from the on-board reservoir. He completed the servicing and then began to transfer fuel from the bladders. Moments later he heard over the interphone, "Something is wrong with number one engine." He scrambled back up to the cockpit and couldn't believe what the engine instruments were telling him. They had lost number one engine. The pilot notified the mission commander who was in a trailing aircraft; then shut down the engine and feathered the prop. The copilot advanced the power to METO on the remaining

engine as the airspeed bled off and the aircraft began to descend from 10,000 feet. The pilot had his hands full trying to control the airplane in night weather conditions. With METO power, the pilot was able to level the airplane at 3700 feet; then as the airspeed slowly built back up he was able to climb to 4100 feet. Some structural icing had been evident prior to the time the engine was shut down. As the aircraft descended to a lower altitude, the outside air temperature was warm enough to rid the airplane of ice. When the pilot had the airplane under firm control, he told the copilot and flight mechanic to put on anti-exposure suits, LPUs, and parachute harnesses. After turning to the flight deck, the copilot flew the airplane while the pilot donned his survival gear. The airplane was equipped with parachutes (chest packs) and a seven man life raft carried in the cargo compartment.
